AEI CONFERENCE 2017

TOWARD A STRUCTURAL COMPREHENSION OF AN 18TH CENTURY SPANISH COLONIAL STONE MASONRY MONUMENT: THE CHURCH OF MISSION SAN JOSE Y MIGUEL DE AGUAYO, TEXAS

Angela Lombardi & Saadet Toker-Beeson
University of Texas at San Antonio

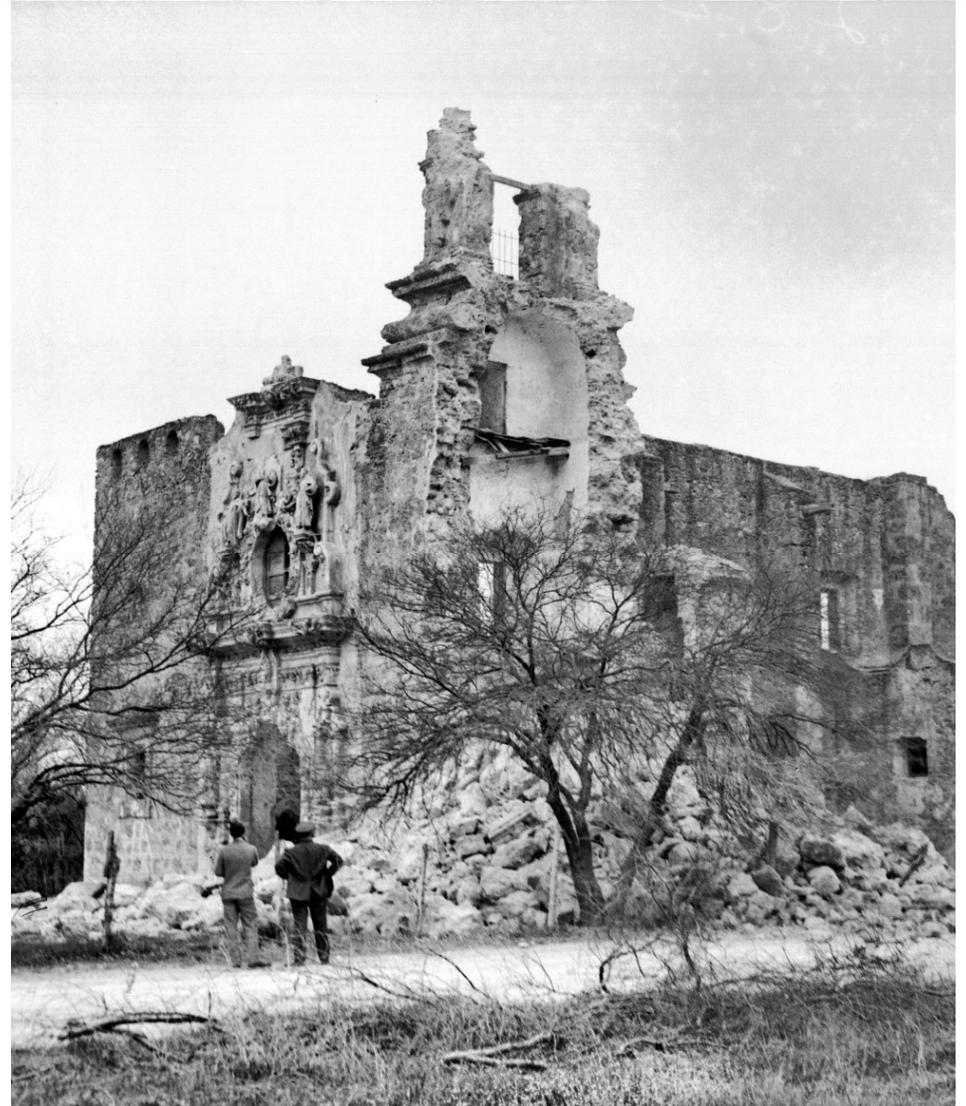
The church with vaults, dome and tower collapsed

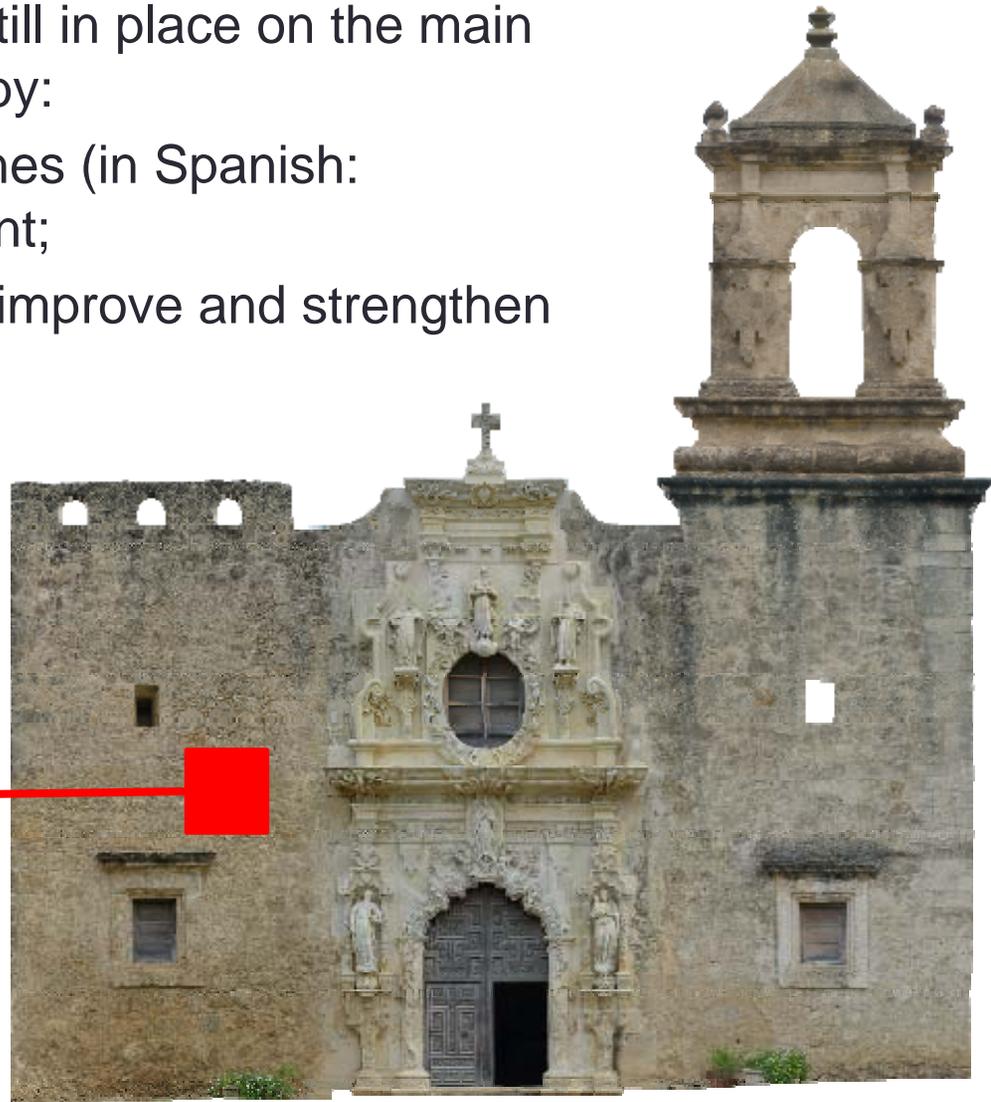
- Original 18th century masonry, still in place on the main façade (west), is characterized by:
 - - presence of small livers of stones (in Spanish: *rajuelas*) between the mortar joint;
 - - irregular horizontal courses to improve and strengthen the masonry.
- -Original mortar is lime based,
- with yellowish color and friable.
- Façade is finished
- with remnants of stucco.

Masonry samples are 1mt x 1mt

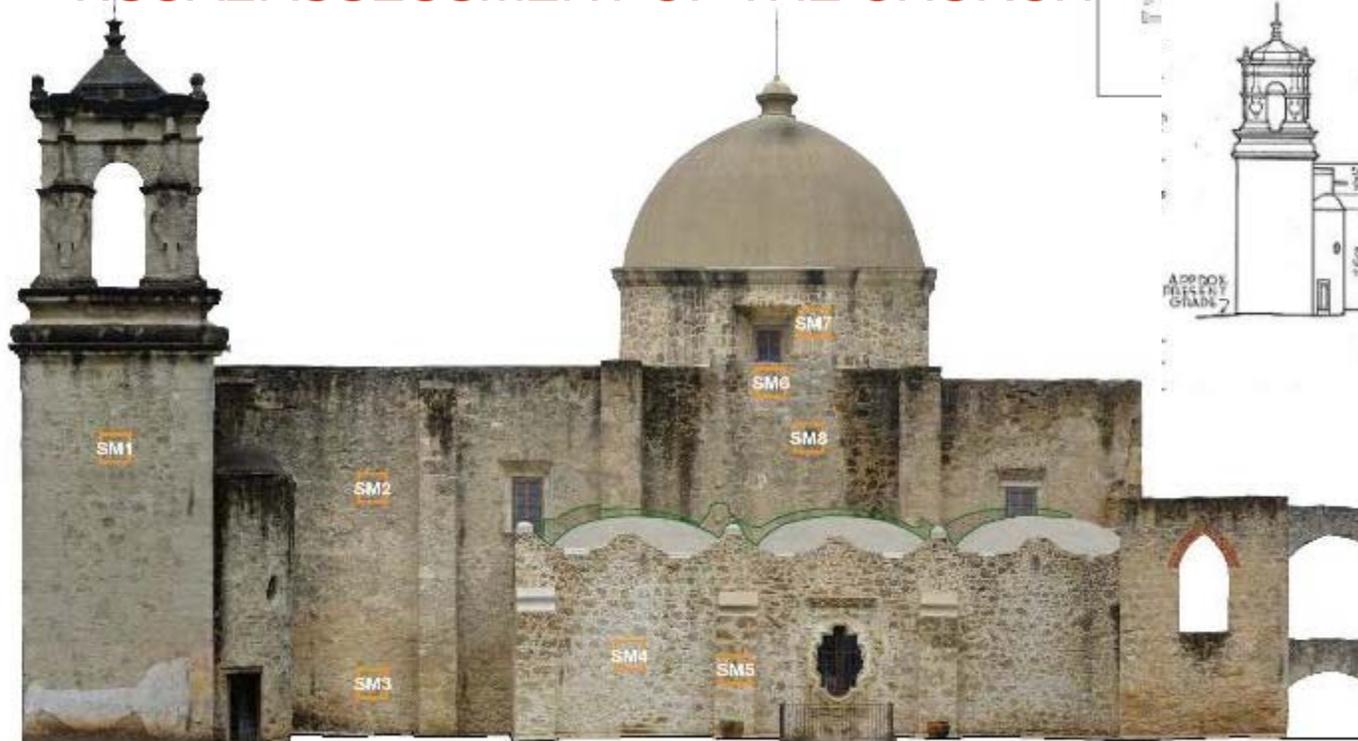
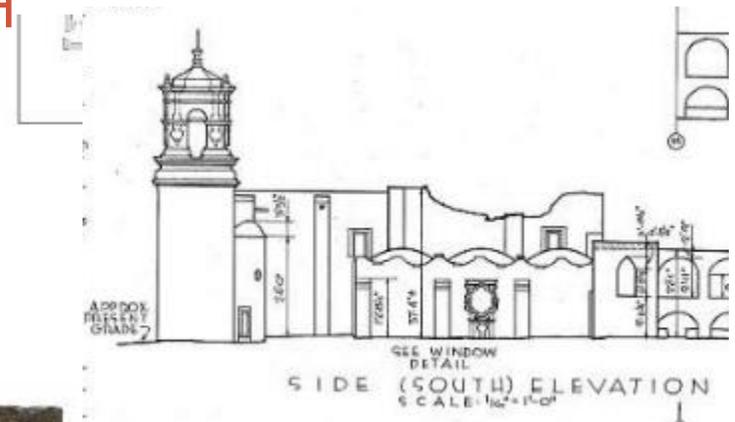
View of southern façade with masonry samples units

- Rubble masonry is commonly adopted in 18th century buildings both in Mexico and Europe. Both mortar and small livers of stones into the mortar joints have key role in improving mechanical characteristics.

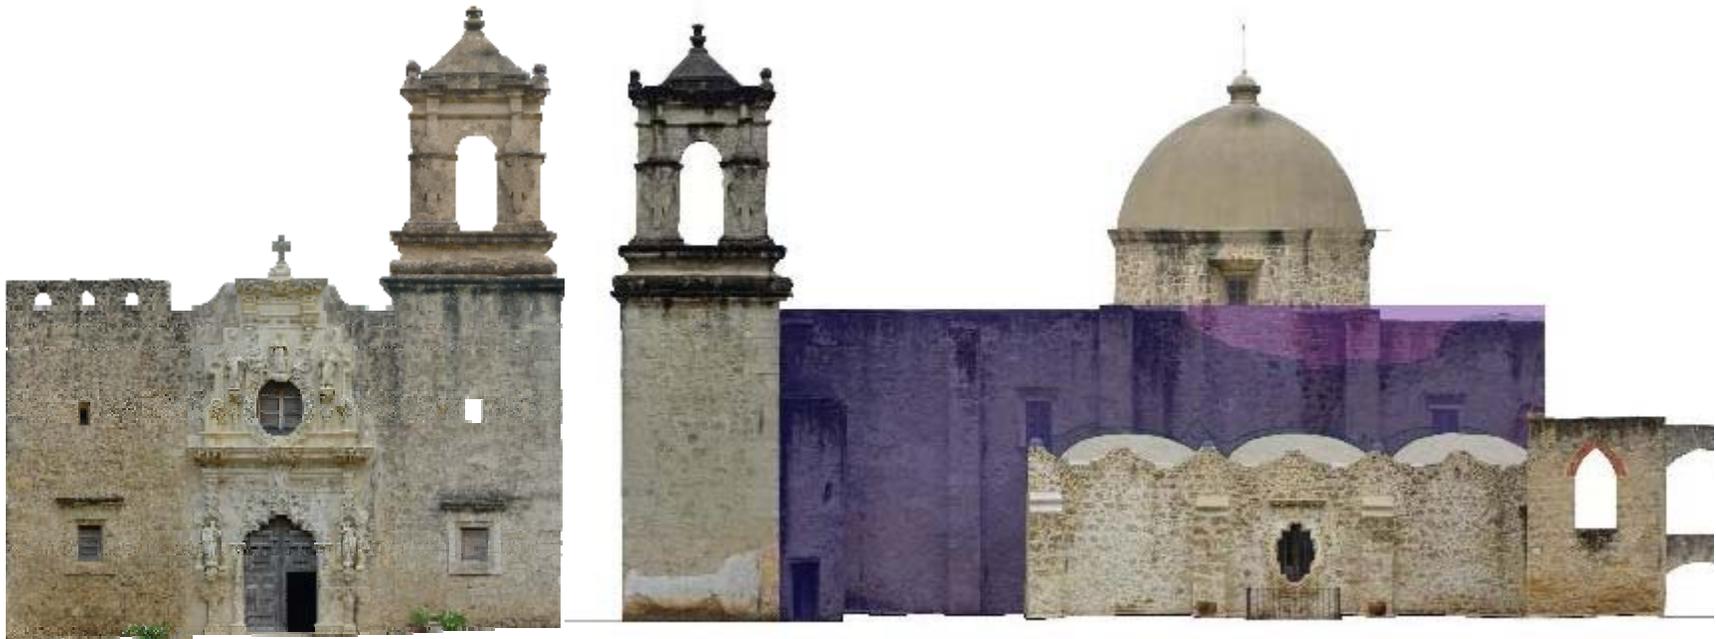
In this elevation: In blue: original walls

- **RECONSTRUCTED 20TH CENTURY MASONRY IN THE AREA OF THE BELL TOWER:**
 - Very similar to the original one, with no use of small stone livers.
 - Ashlar quoins.

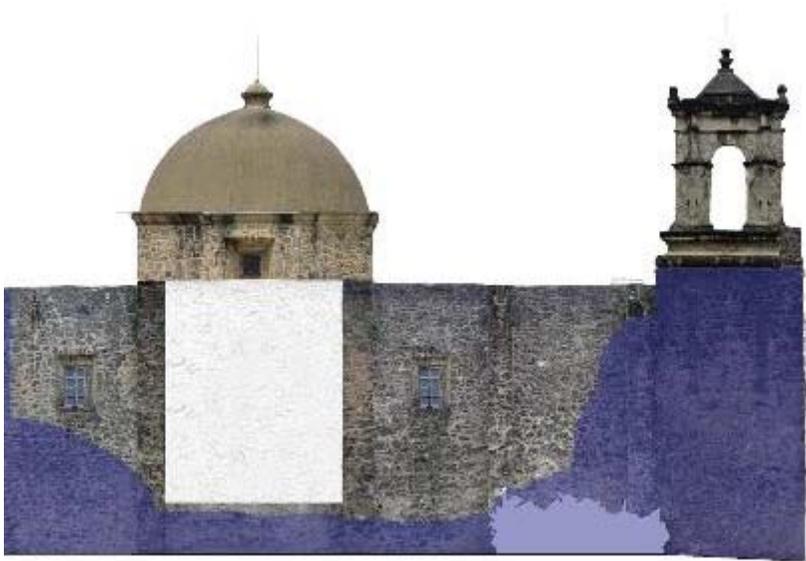
- Reconstructed 20th century masonry on the northern wall is also made of irregular lime stones.
- - No small slivers of stones or horizontal courses have been observed;
- - Possible adoption of cement-based mortar;

Northern photo elevation:
In blue - original walls

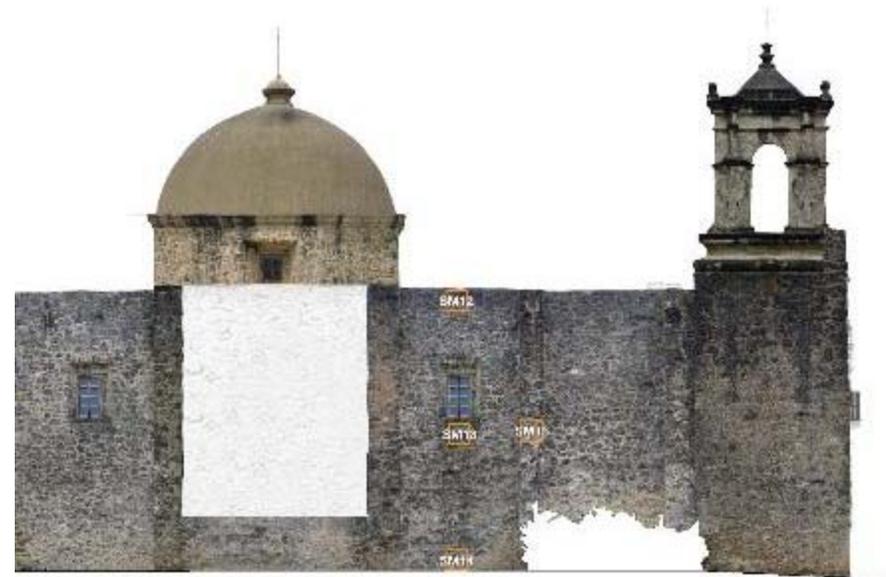
Northern photo elevation with masonry
Samples

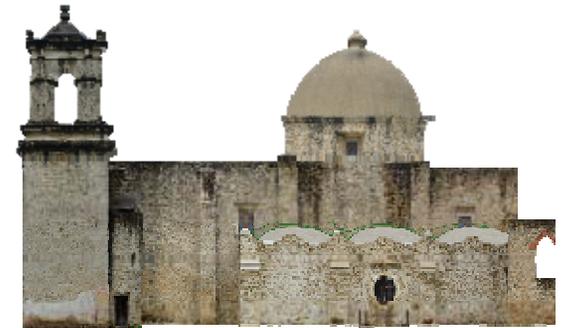
- **RECONSTRUCTED 20TH CENTURY MASONRY ON THE DRUM:**
 - quasi squared blocks laid in parallel with horizontal courses;
 - for the mortar, possible adoption of cement-based mortar.

View of the dome in the southern facade

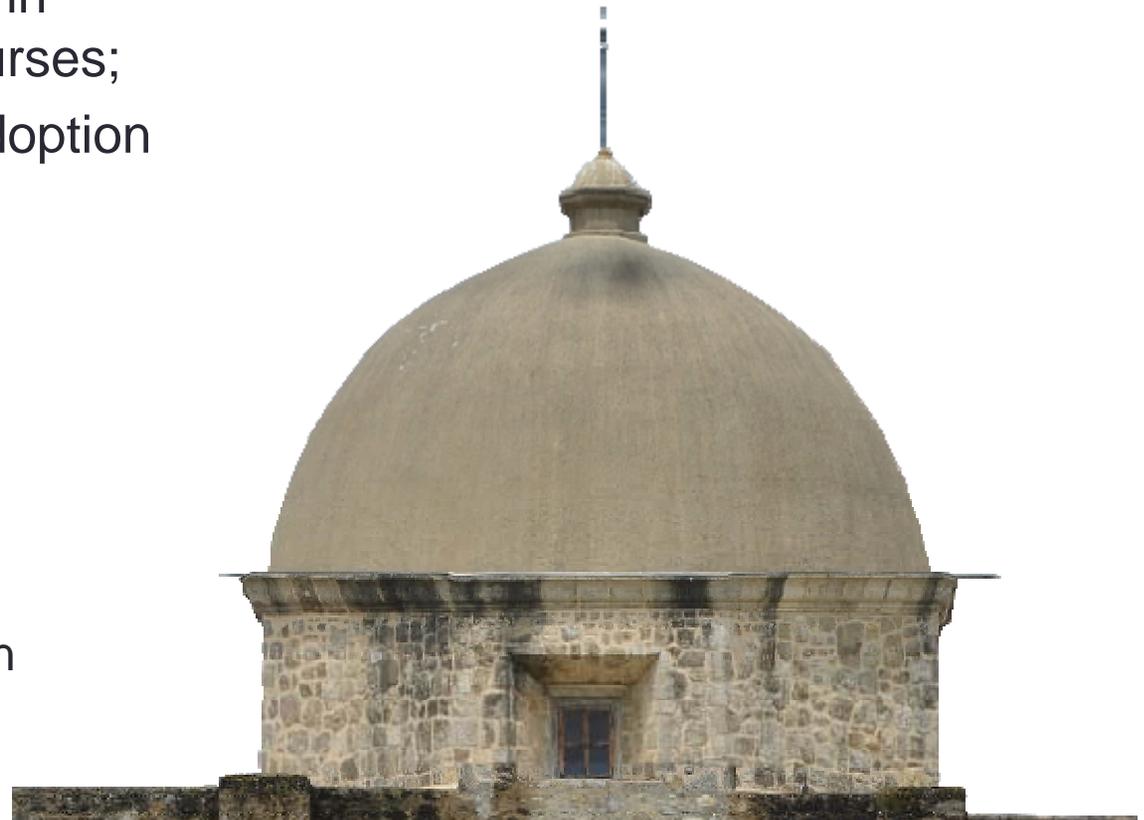
Notes on reconstruction

The HABS drawings, drafted by Harvey P. Smith after the church reconstruction, show an extremely thin dome section, the adoption of reinforced concrete.

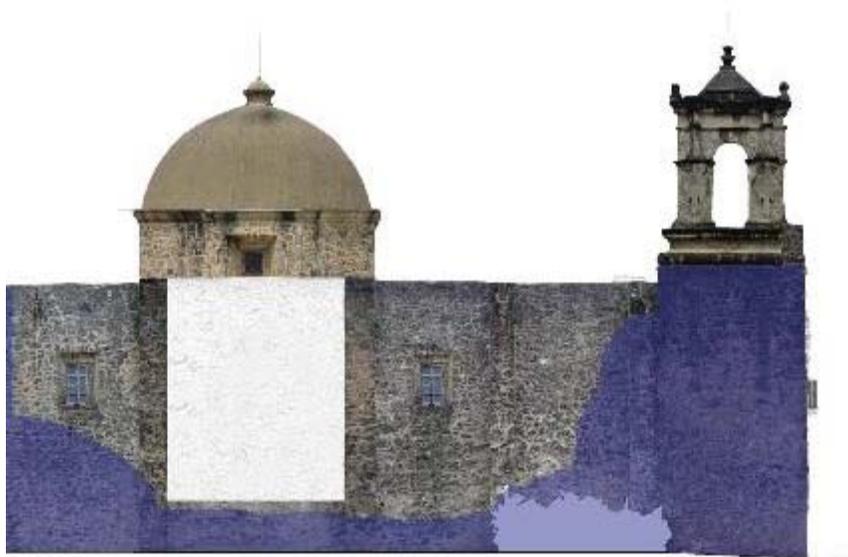
- From the building survey and analysis,
- it is understood that the northern wall
- was repaired by using rubble stone masonry units, with the adoption of cement based mortar;

Northern photo elevation:
In blue - original walls

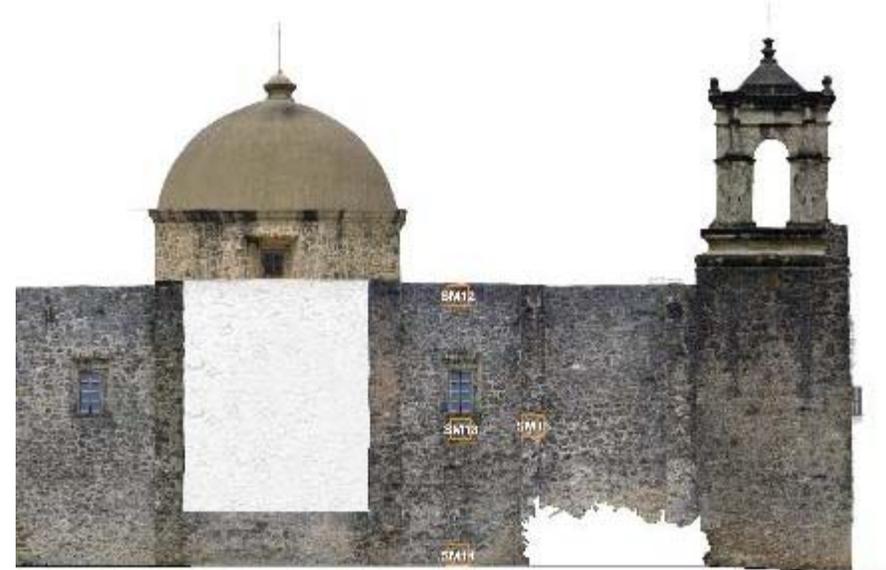
Northern photo elevation with masonry
Samples

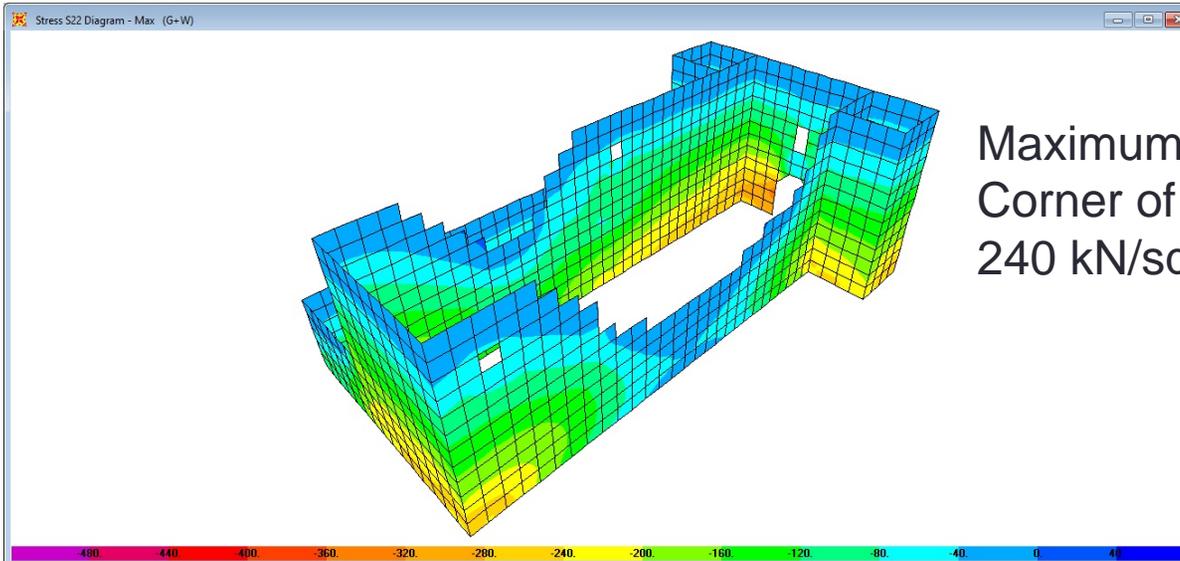
Maximum stress values:
Corner of the bottom of collapsed wall:
240 kN/sqmt – 280 kN/sqmt

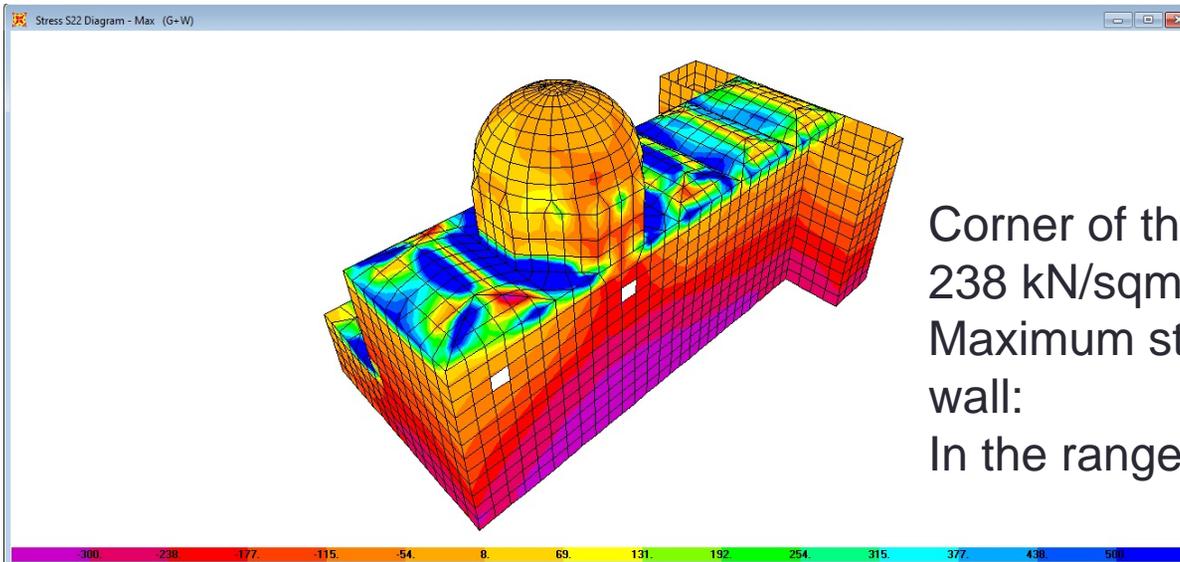
Corner of the bottom of collapsed wall:
238 kN/sqmt – 300kN/sqmt
Maximum stress values at the base of the
wall:
In the range of 300 kN/sqmt- 362 kN/sqmt

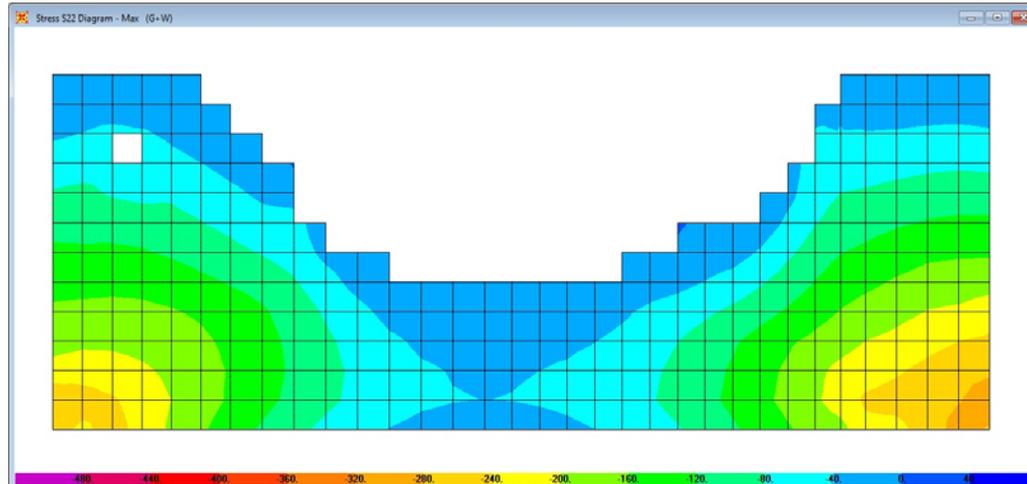
Maximum stress values:
 Corner of the bottom of collapsed wall:
 240 kN/sqmt – 280 kN/sqmt

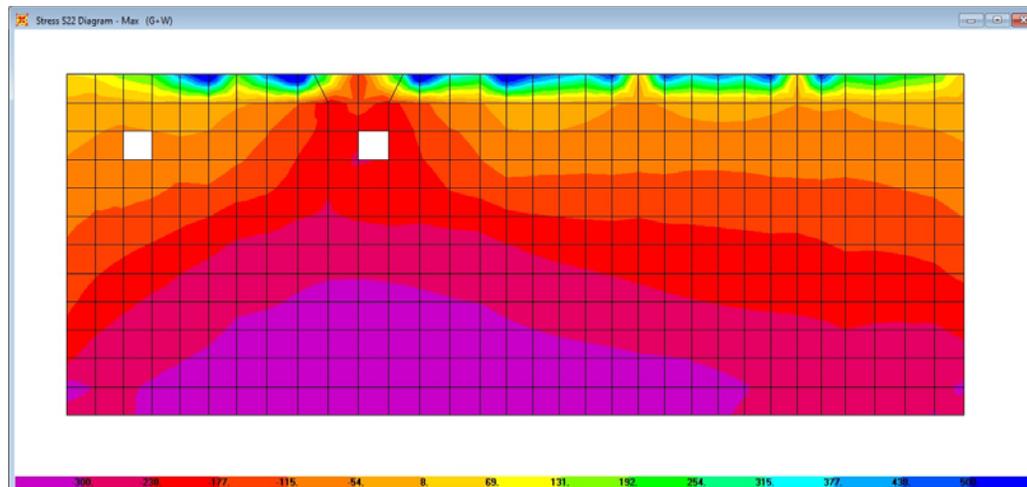
Corner of the bottom of collapsed wall:
 238 kN/sqmt – 300kN/sqmt
 Maximum stress values at the base of the wall:
 In the range of 300 kN/sqmt-362 kN/sqmt
