# **Review and analysis of some of the devastation caused by the earthquake Case Study of Bam Earthquake 2003**

Damage occurred in buildings  
with steel structure

## Lessons Of Seismic Rehabilitation

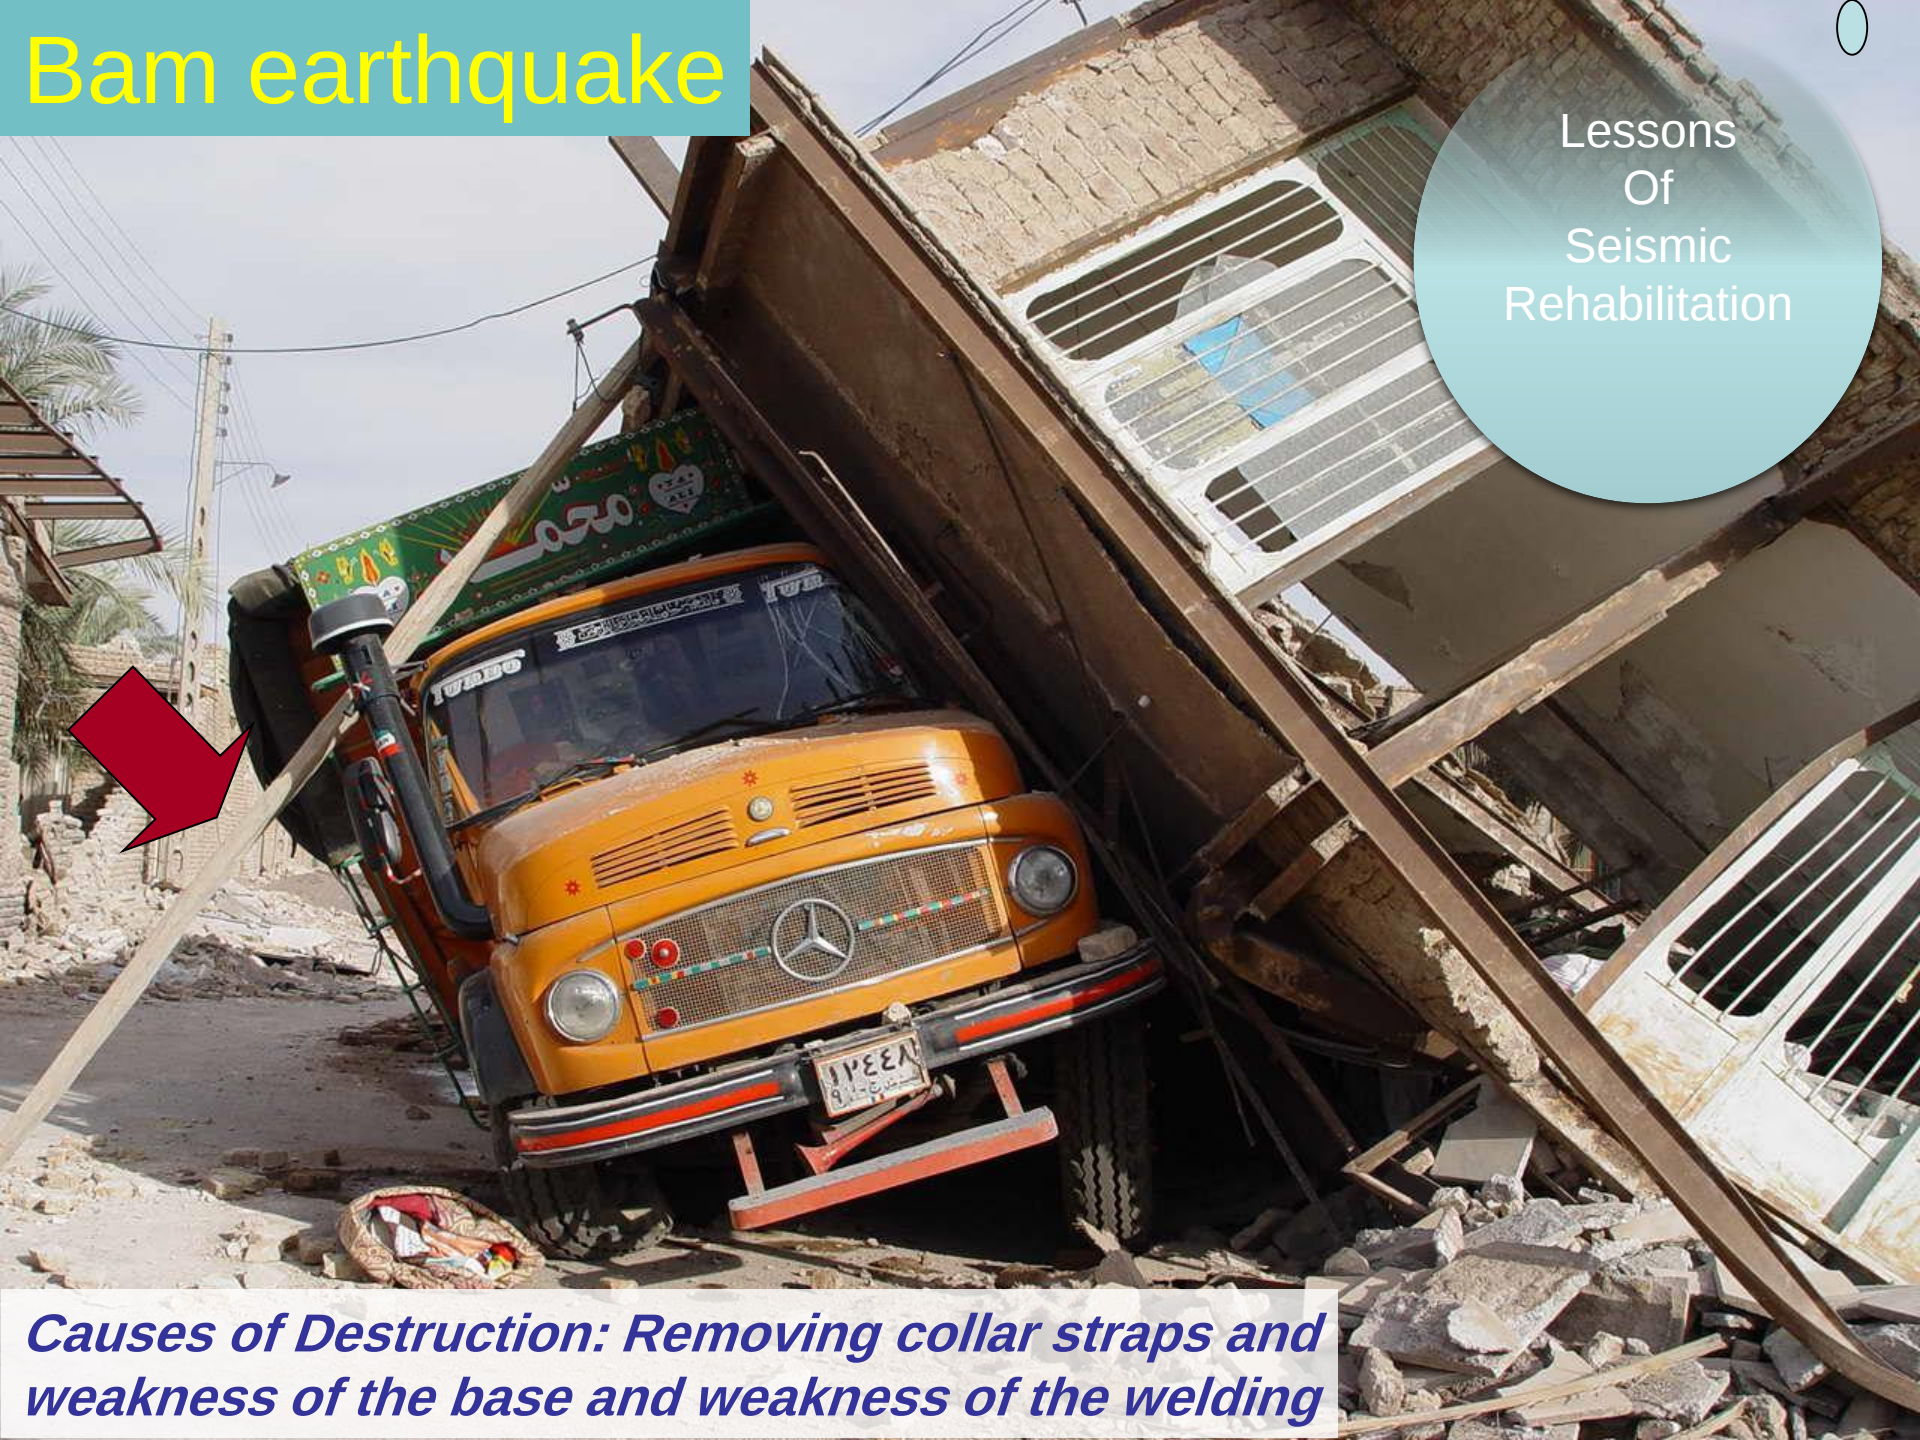
***Causes of Destruction: Removing collar straps and weakness of the base and weakness of the welding***

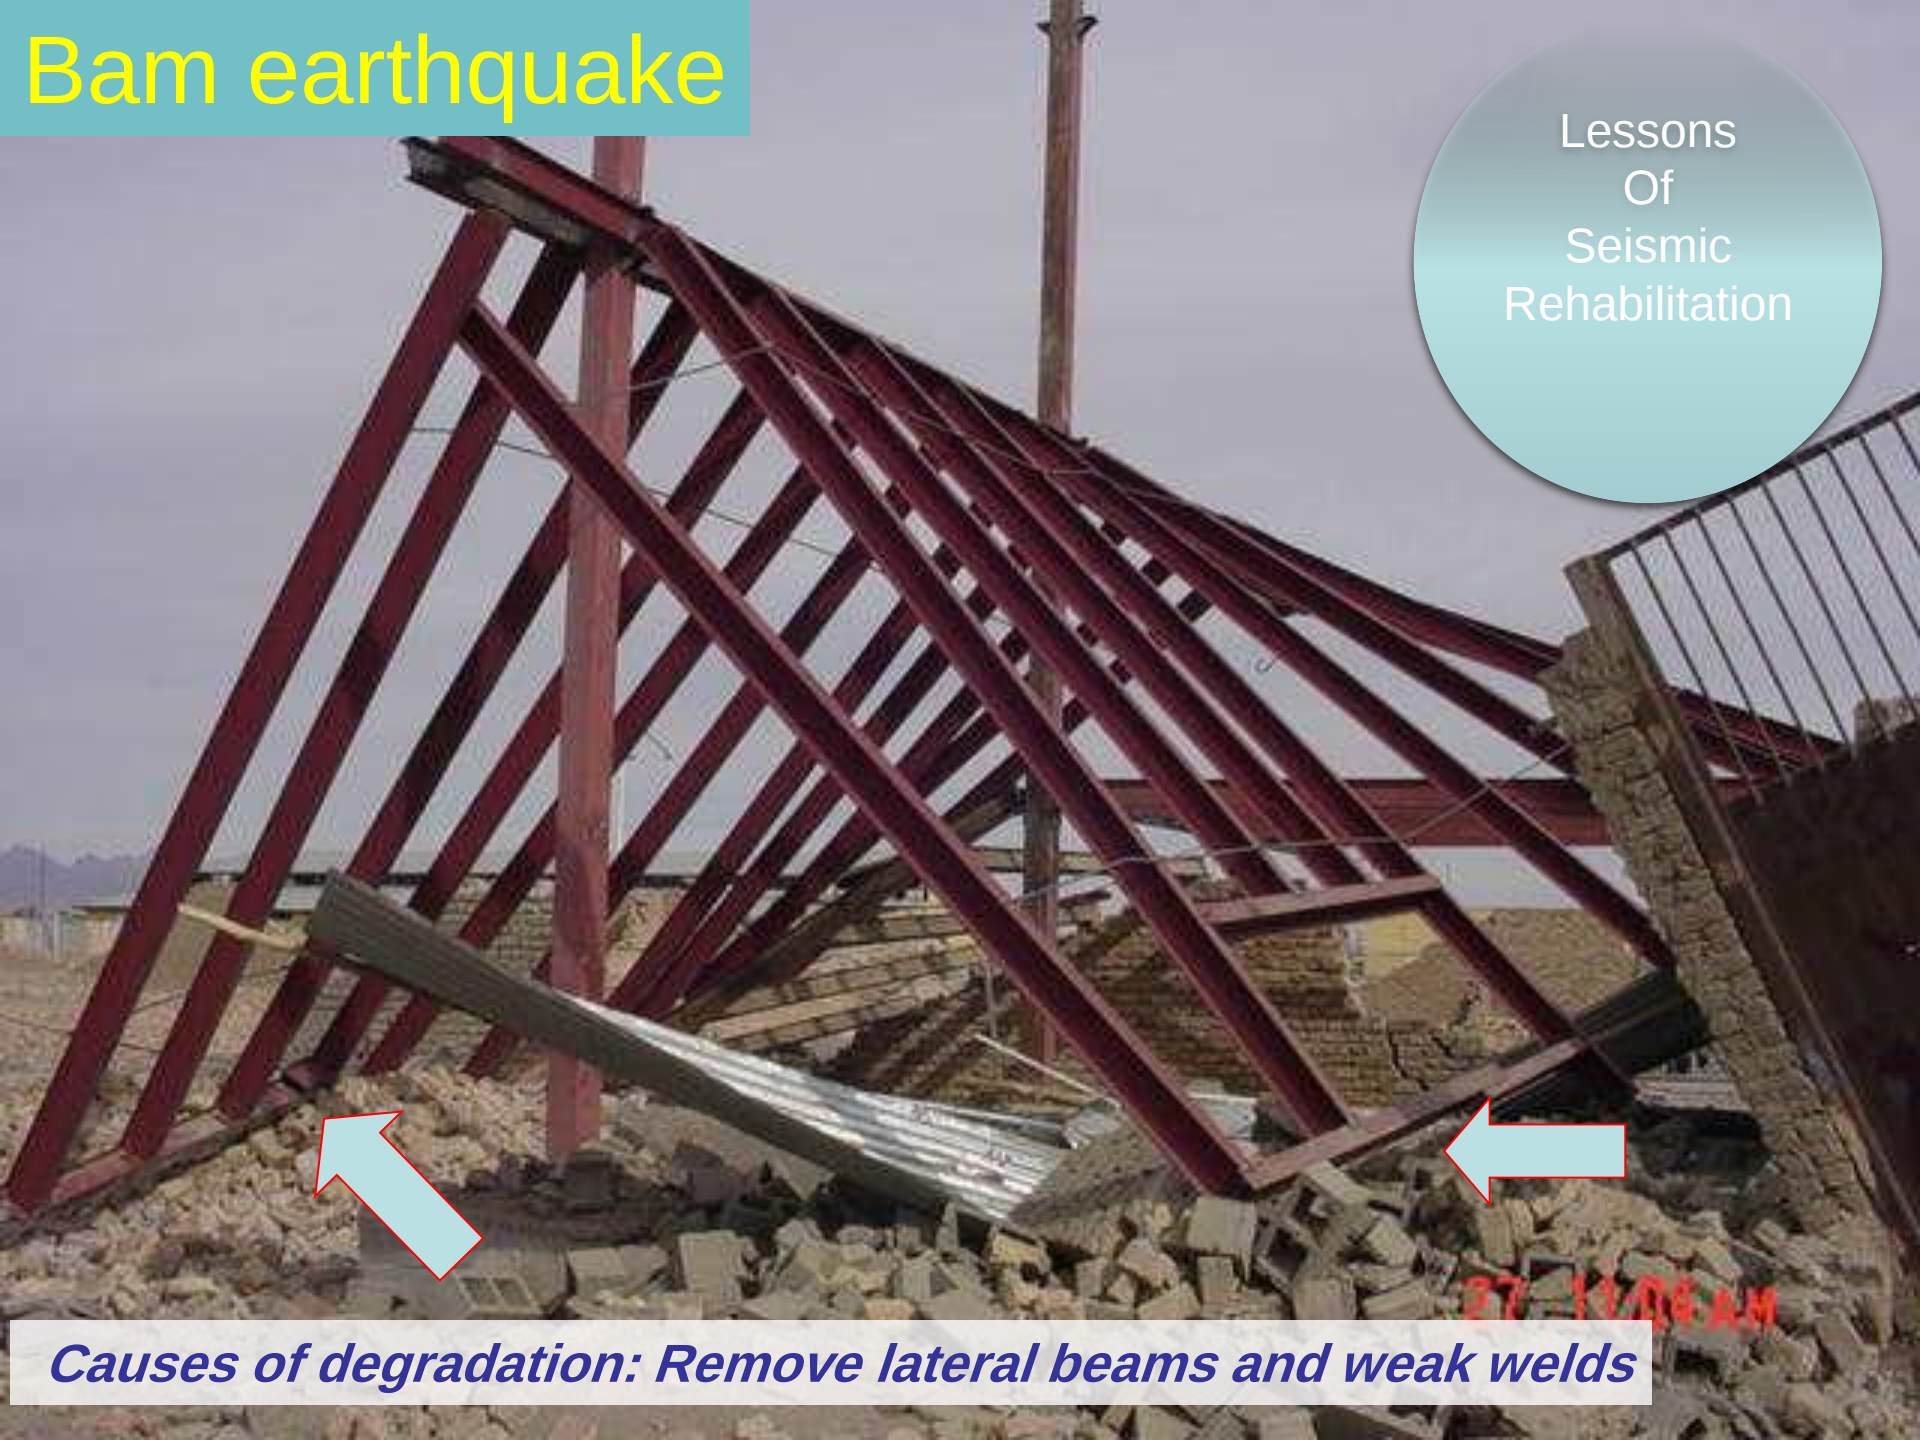
*Causes of degradation: Remove lateral beams and weak welds*

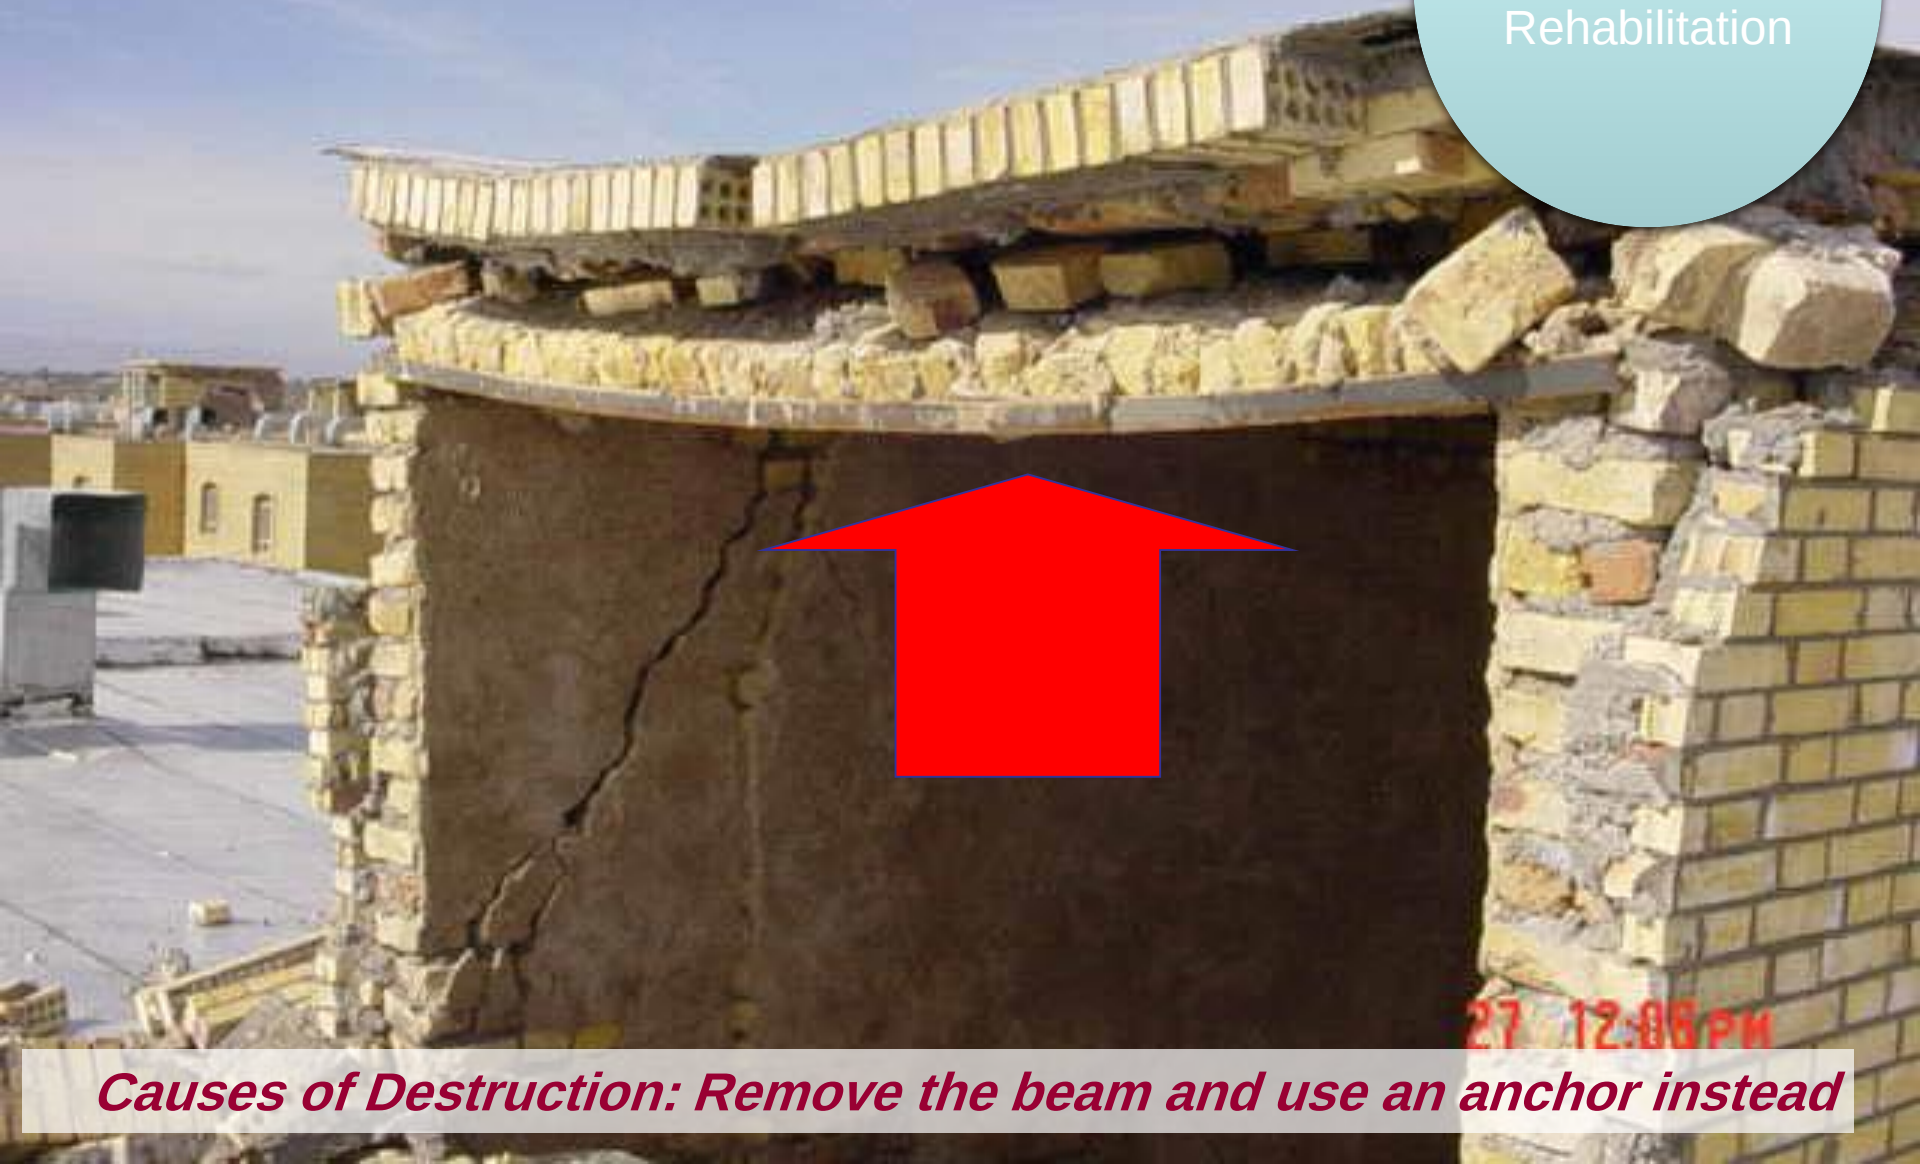
***Causes of Destruction: Remove the beam and use an anchor instead***

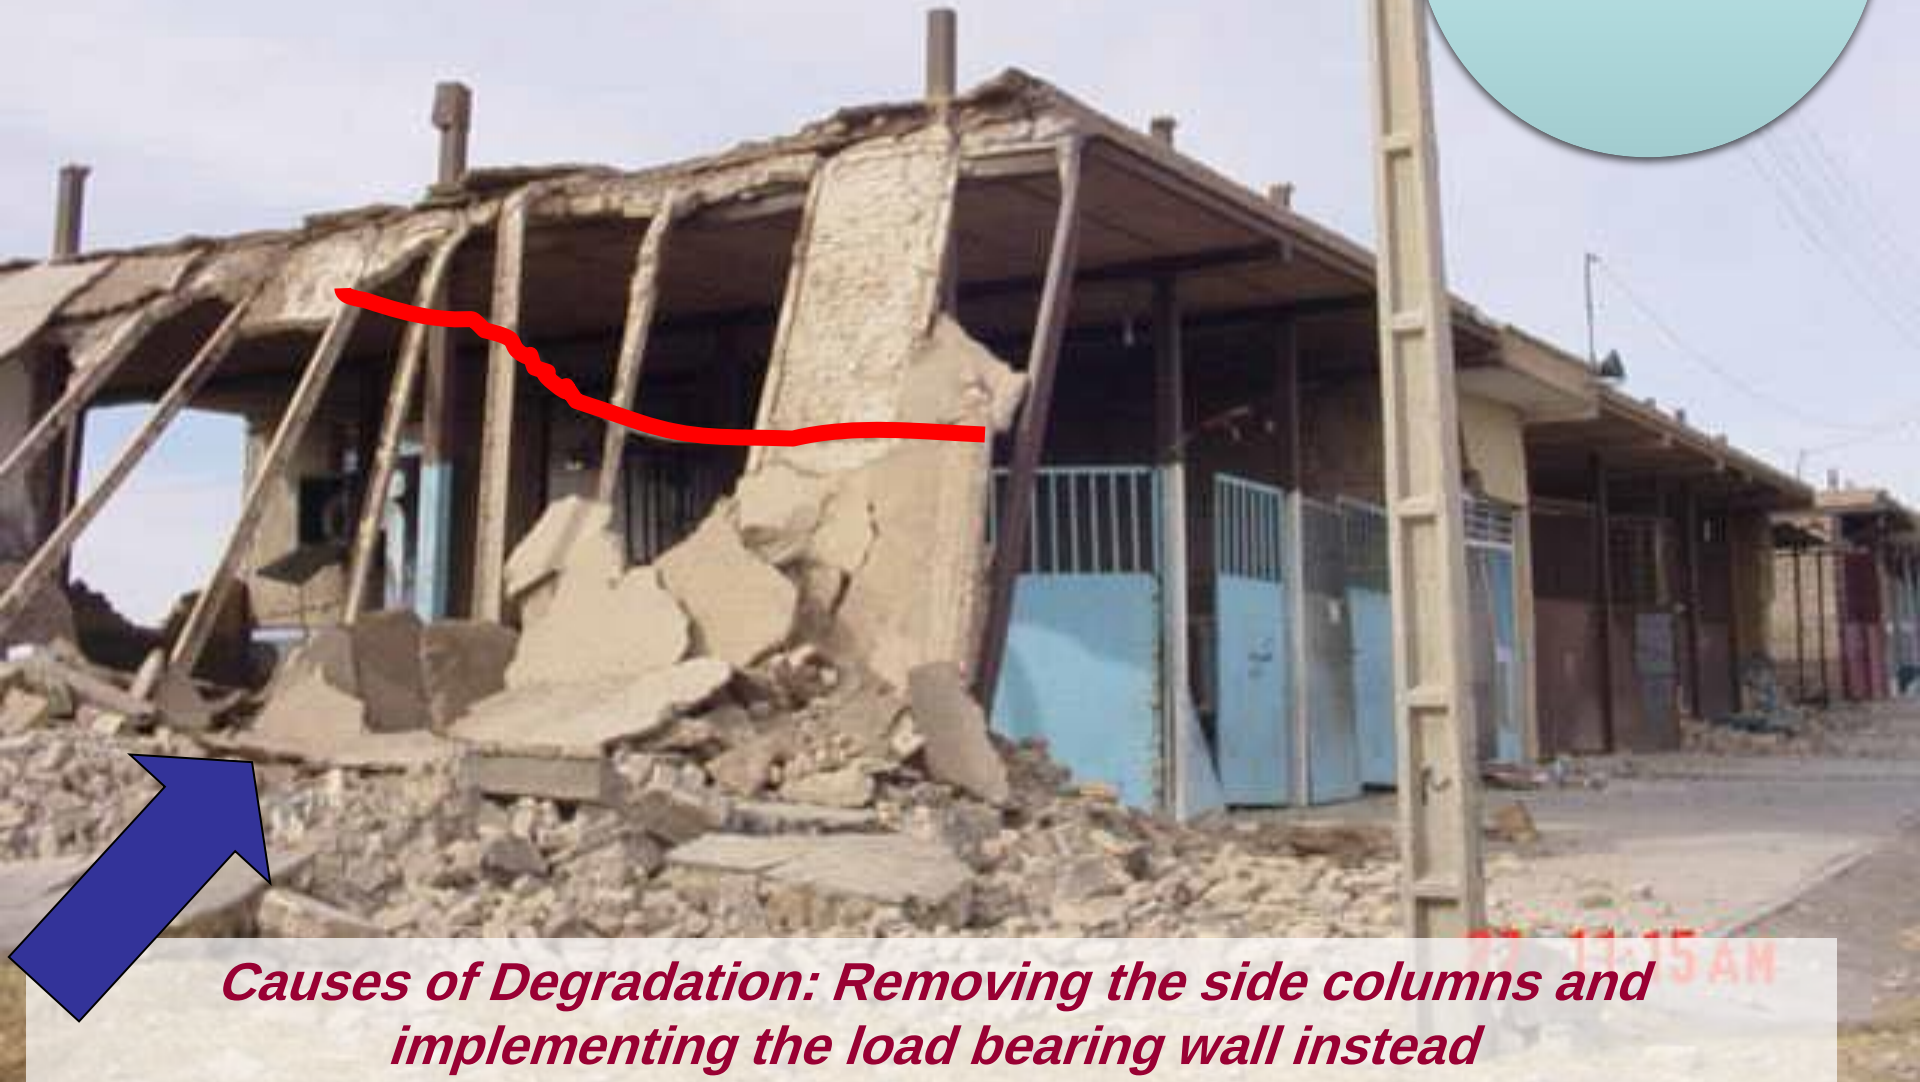
***Causes of Degradation: Removing the side columns and implementing the load bearing wall instead***

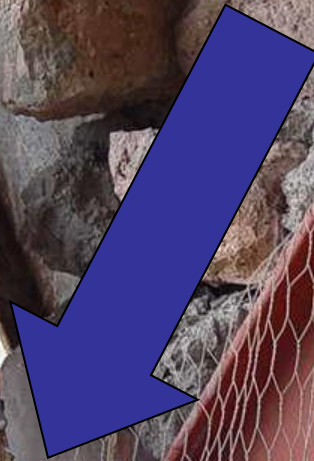
***Causes of degradation: weakness of the welds and their binding plate***

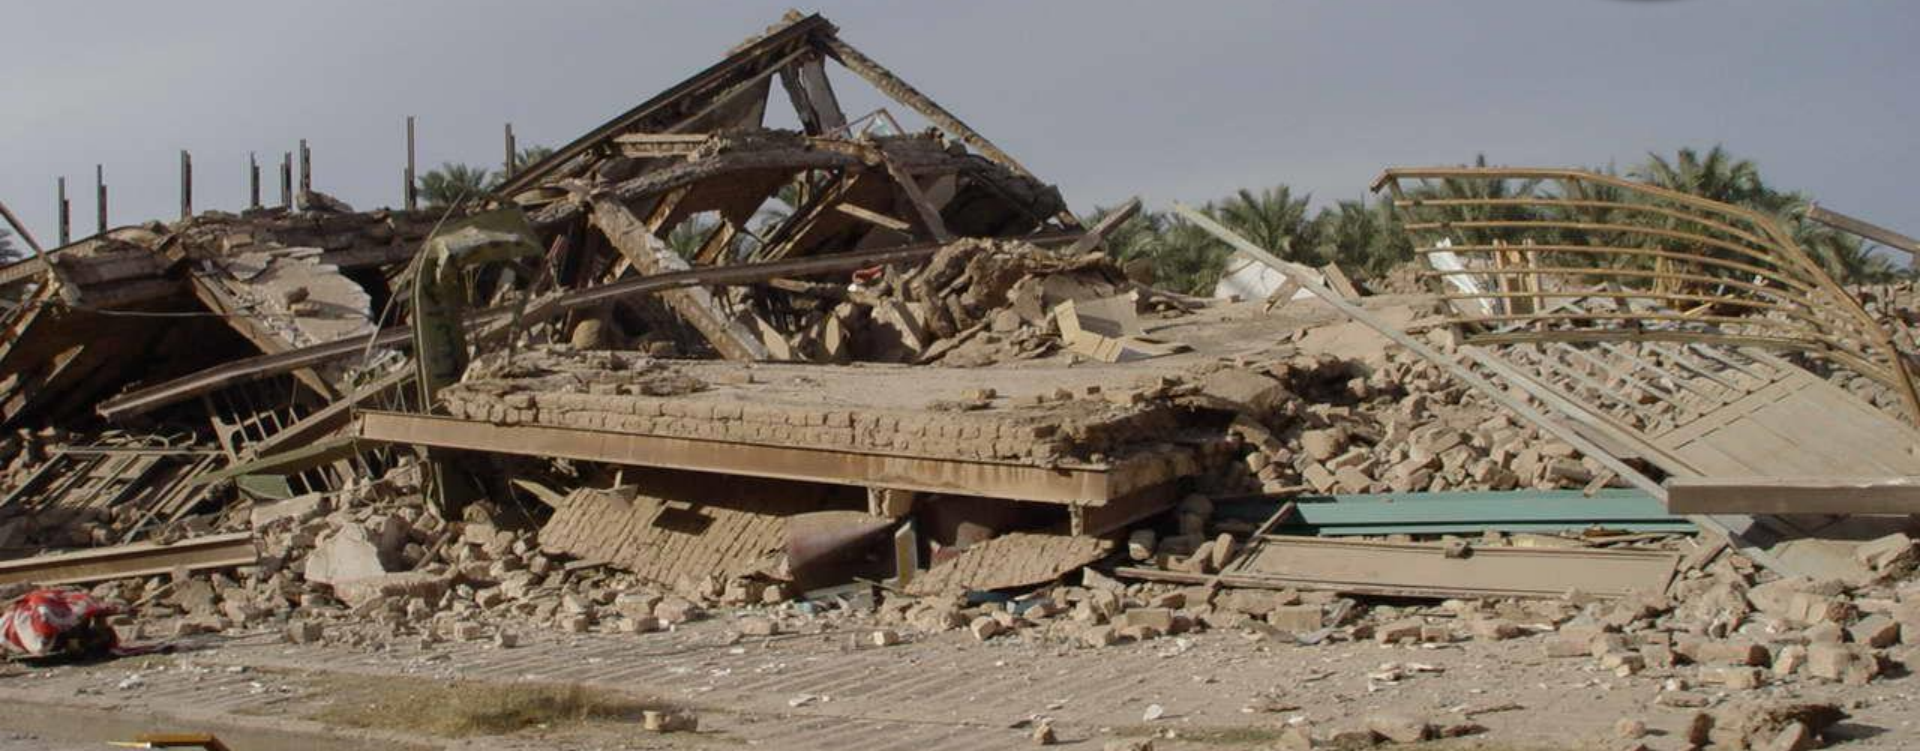
***Causes of Destruction: Remove Extremely Inappropriate Connections and Welding***

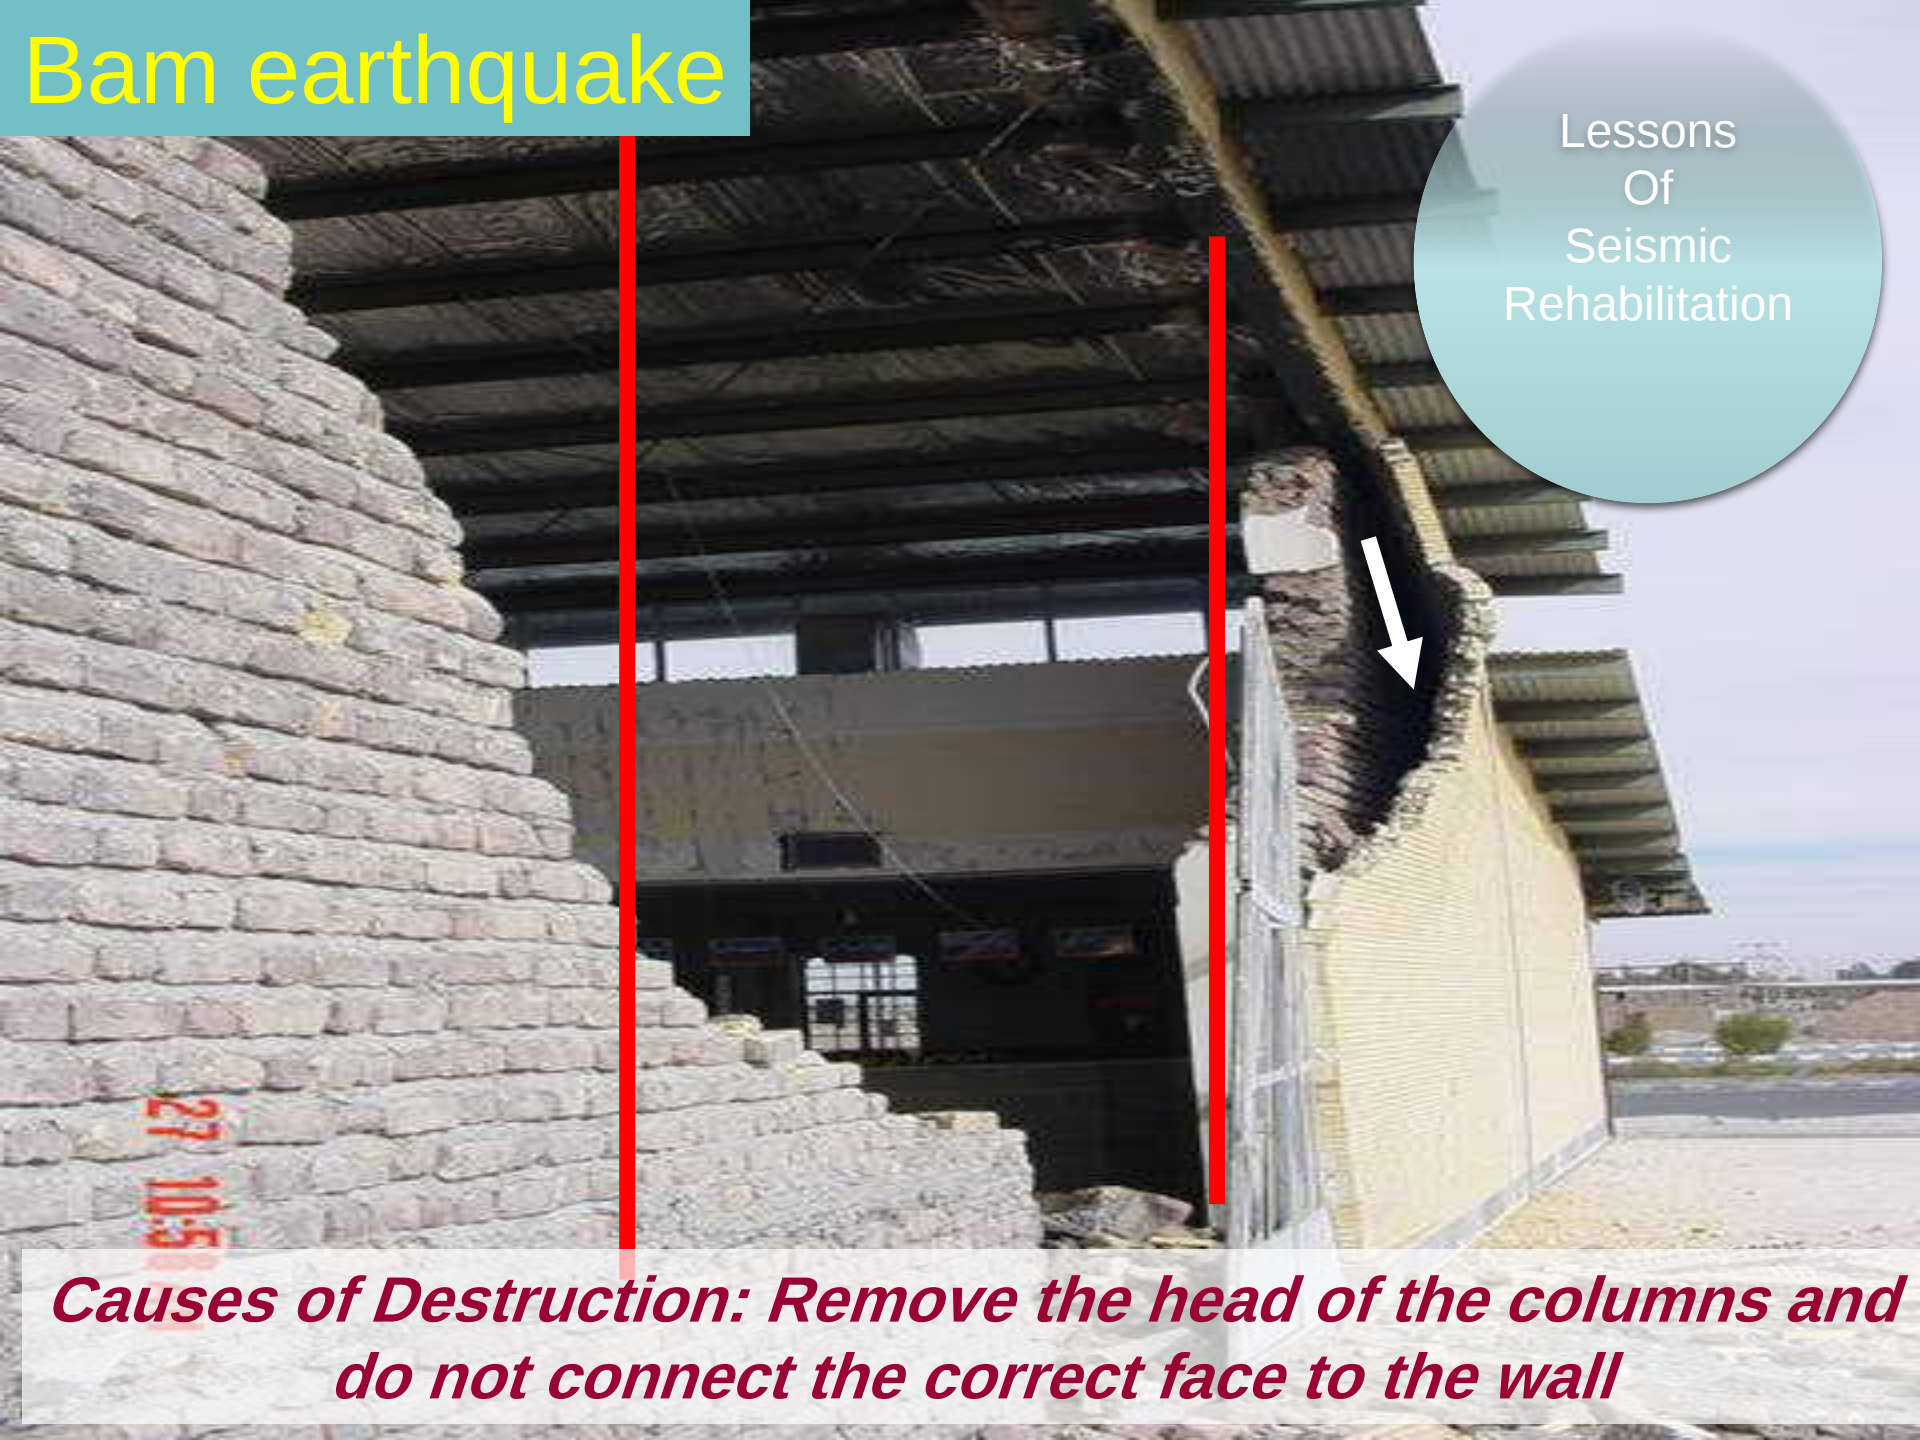
***Causes of Destruction: Remove the head of the columns and do not connect the correct face to the wall***

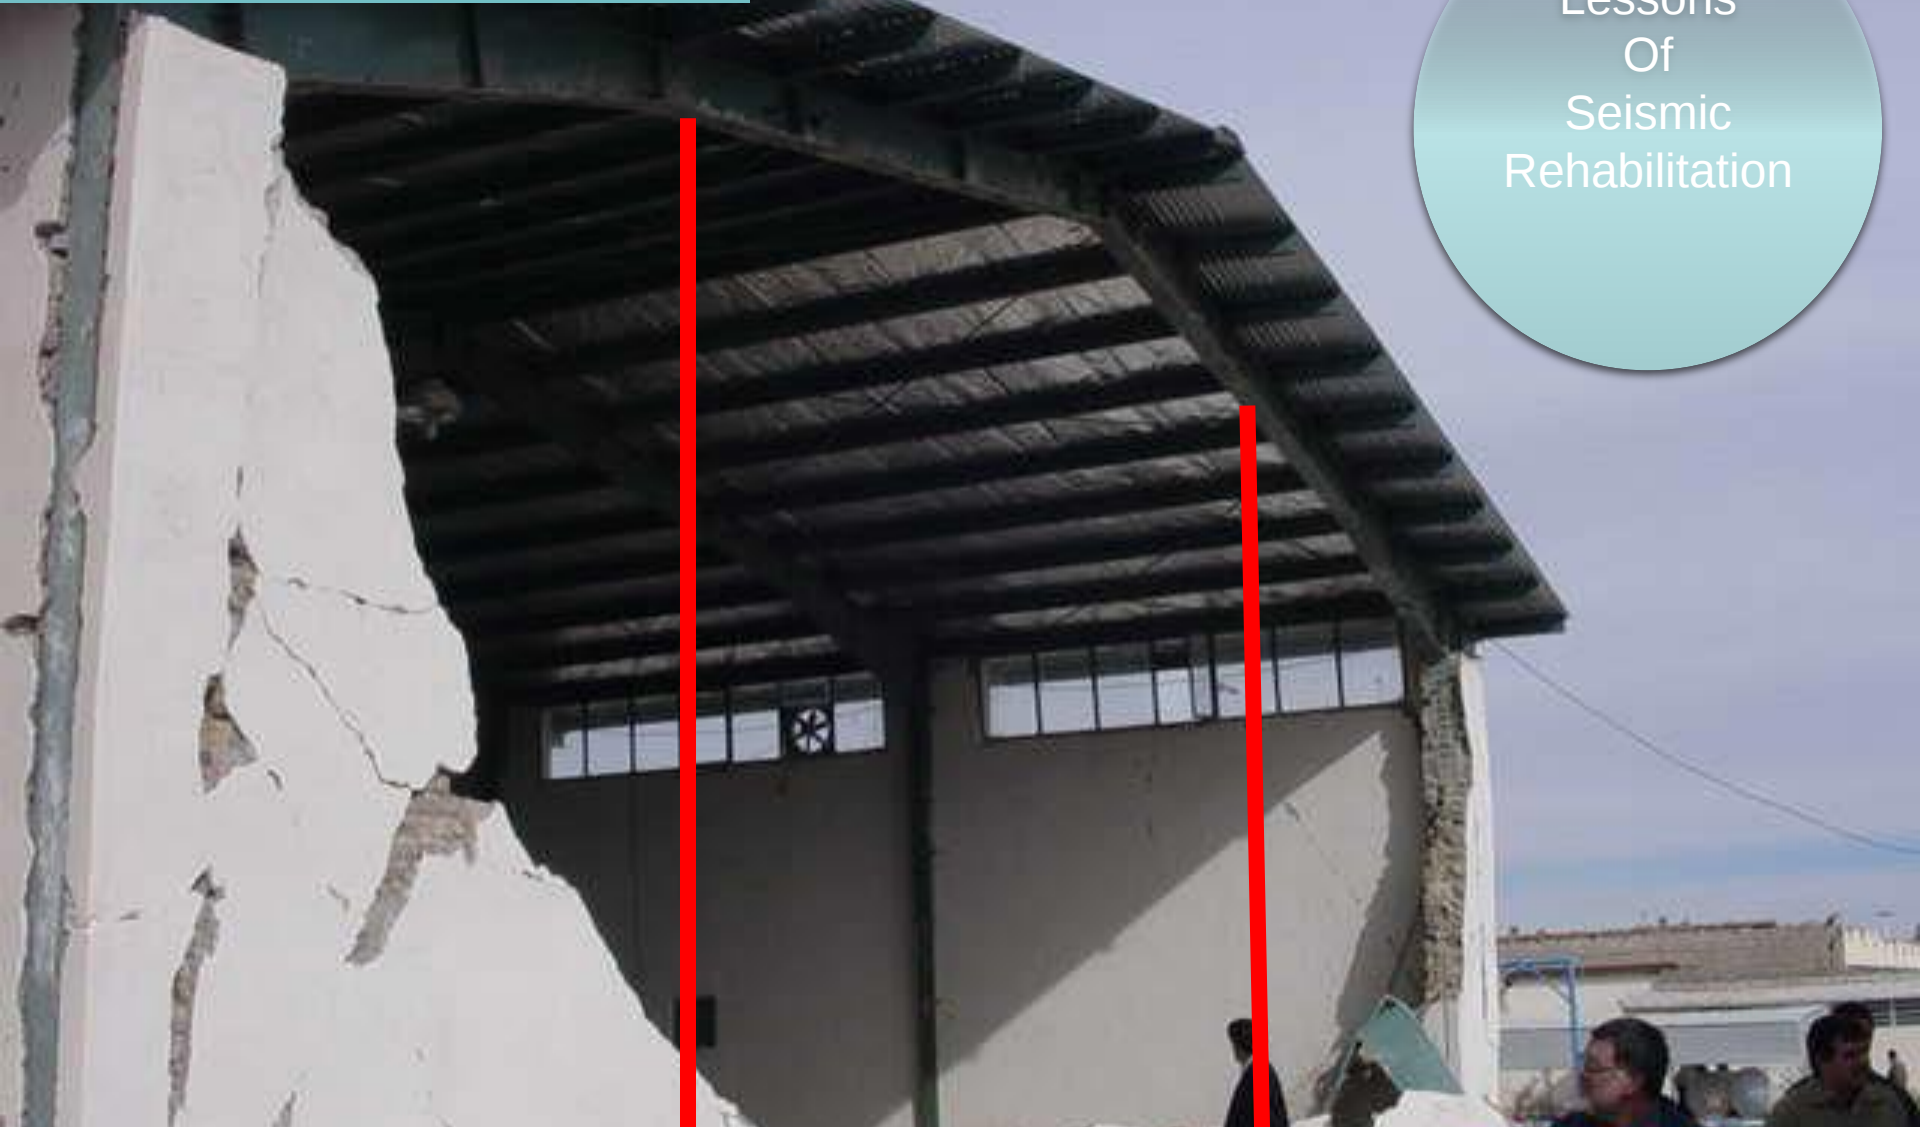
***Causes of Destruction: Remove the head of the columns and do not connect the correct face to the wall***

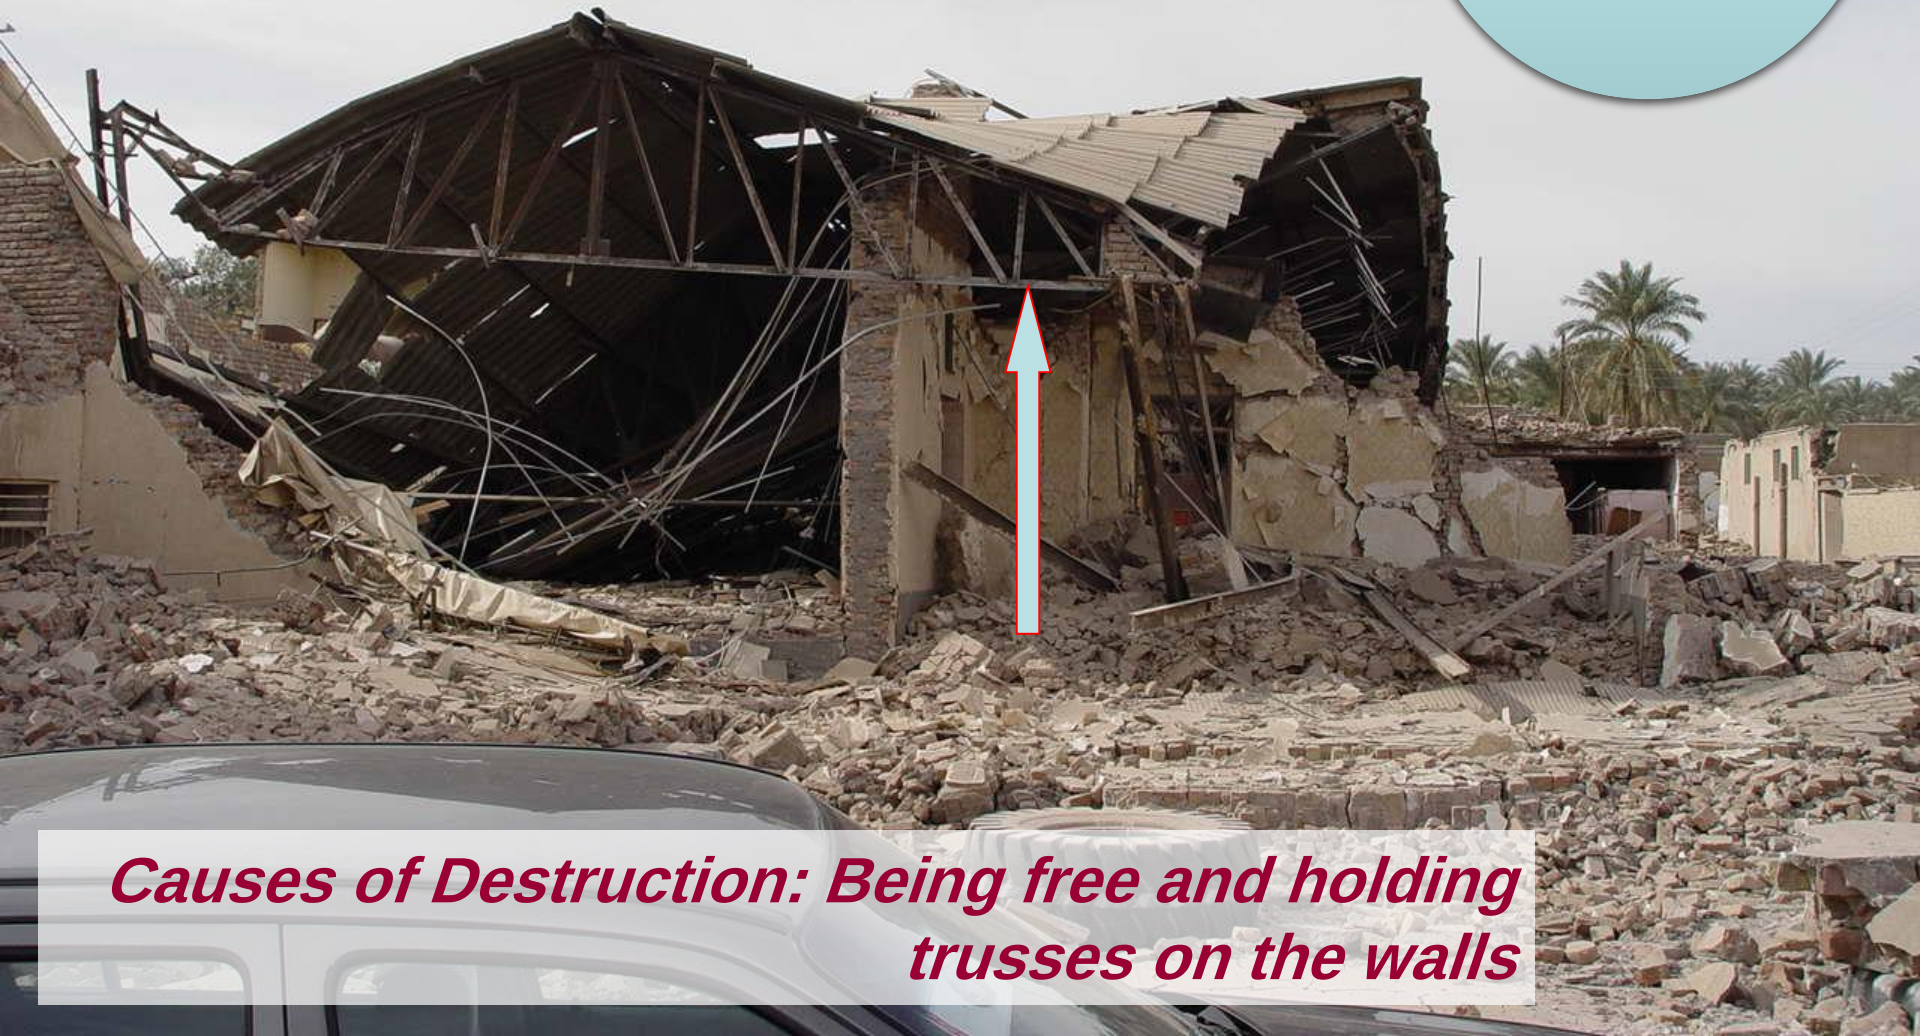
***Causes of Destruction: Being free and holding trusses on the walls***

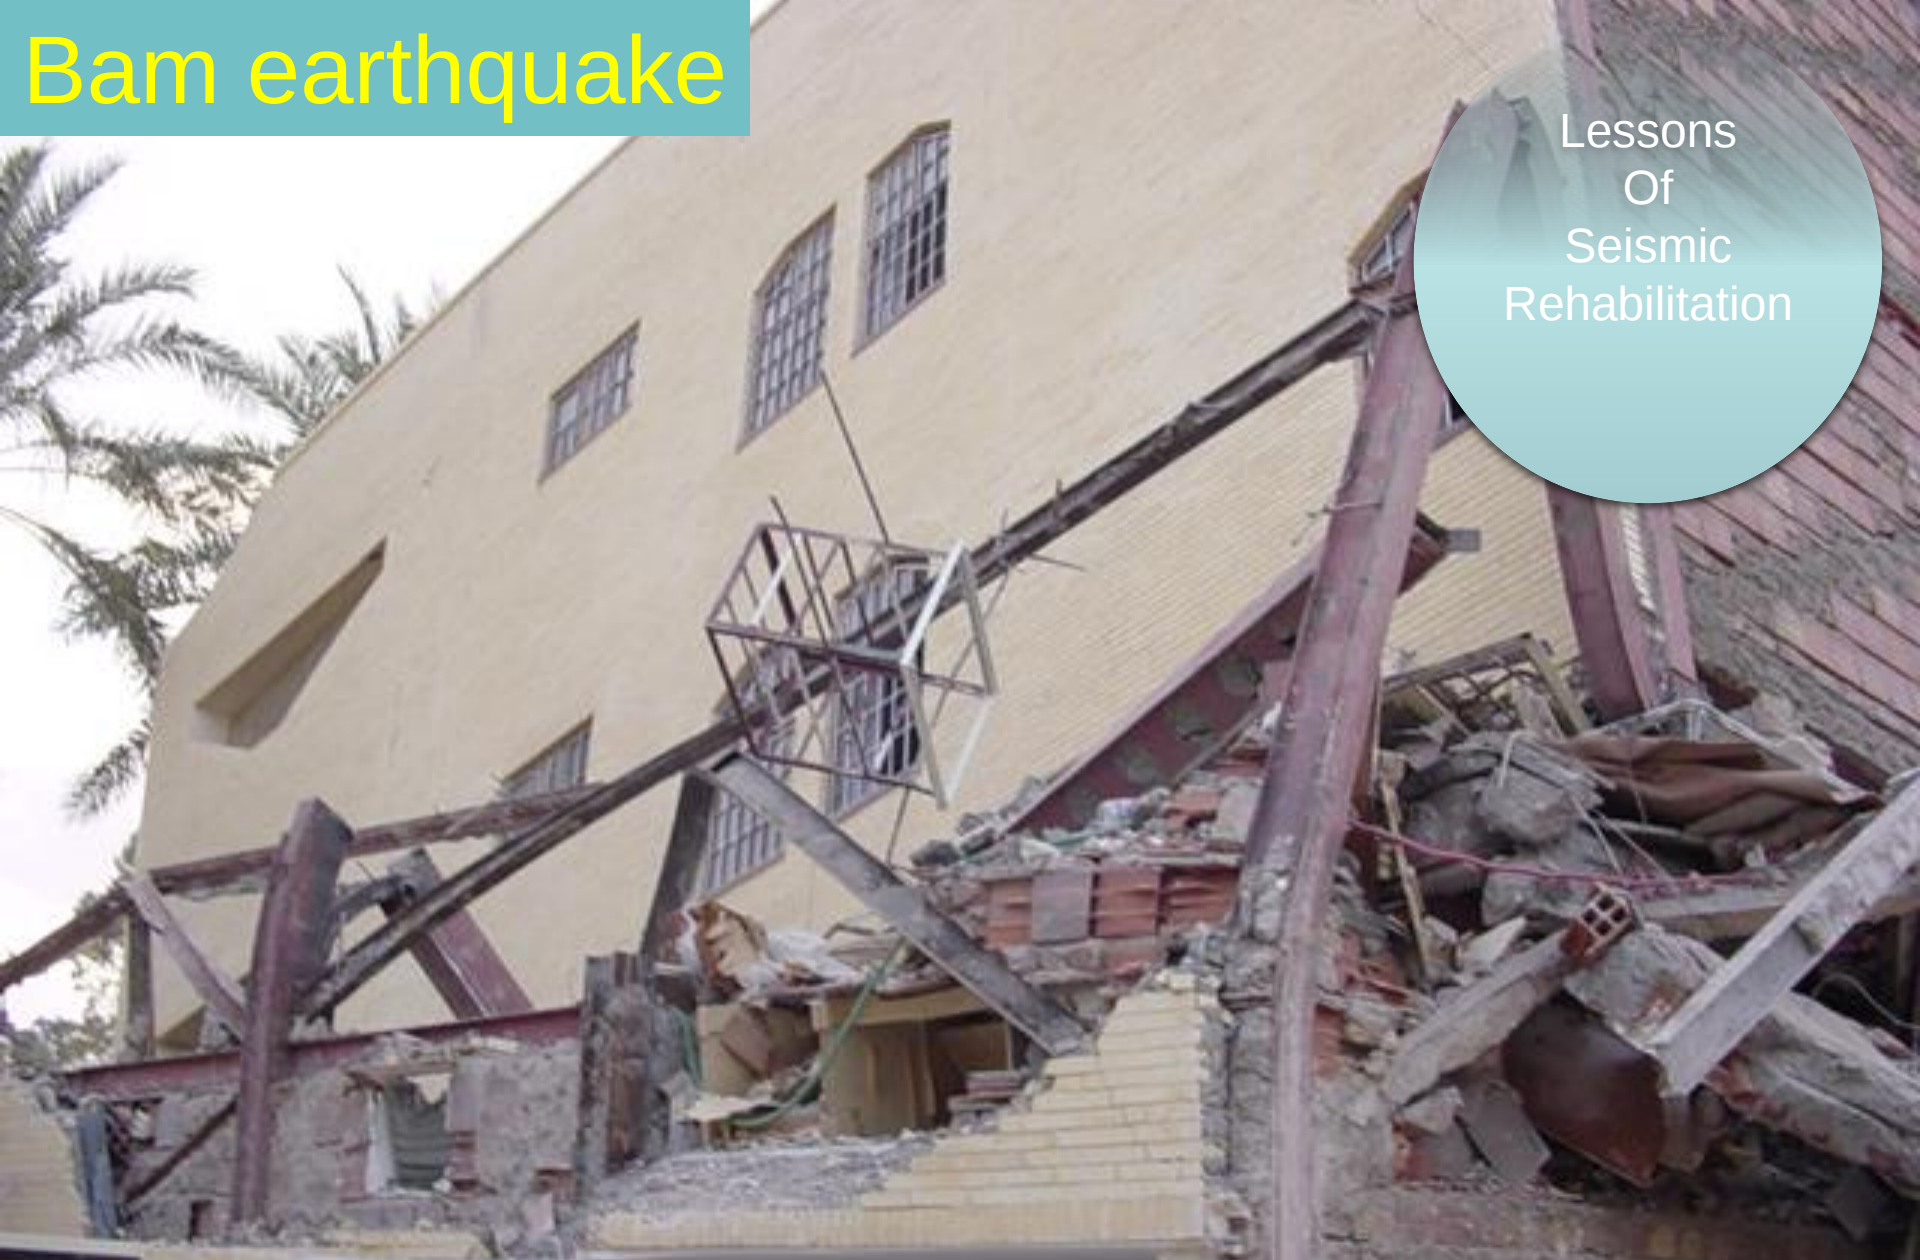
***Causes of damage: Improper welding of the base to the base plate and a plurality of joints to the columns.***
