# **Review and analysis of some of the devastation caused by the earthquake Case Study of Bam Earthquake 2003**

Damage occurred in buildings  
with steel structure

## Lessons Of Seismic Rehabilitation

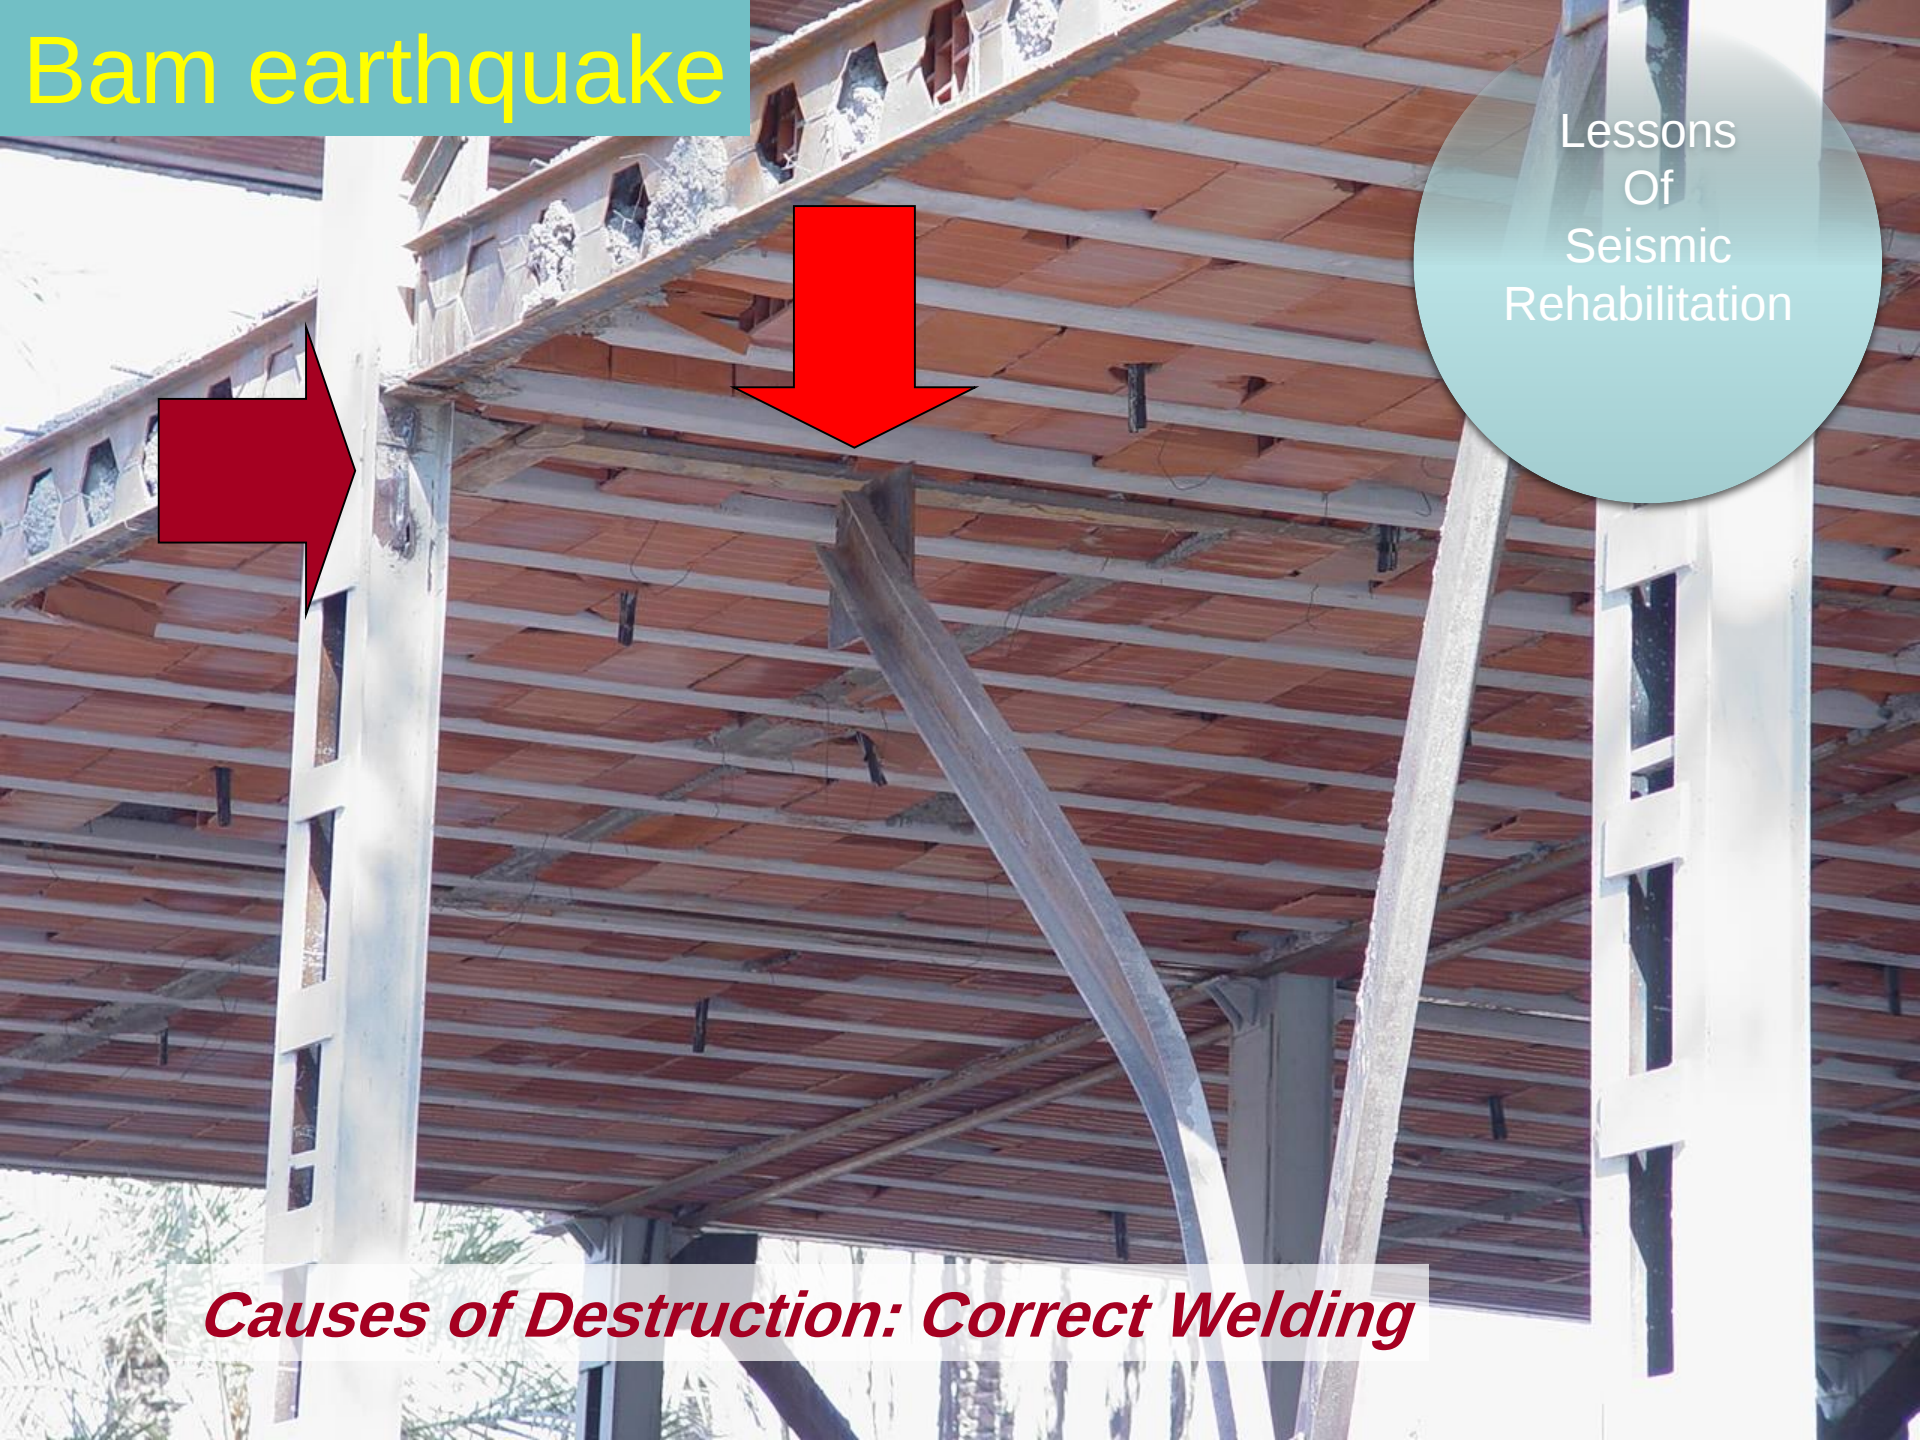
***Causes of Destruction: Correct Welding***

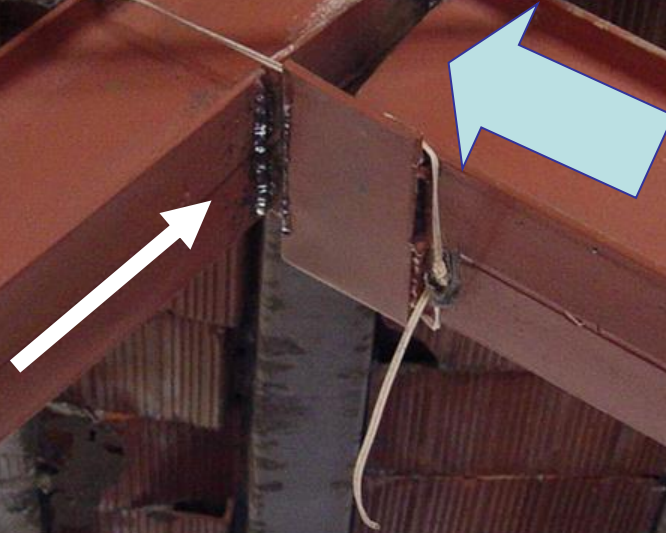
***Causes of Destruction: Correct Welding***

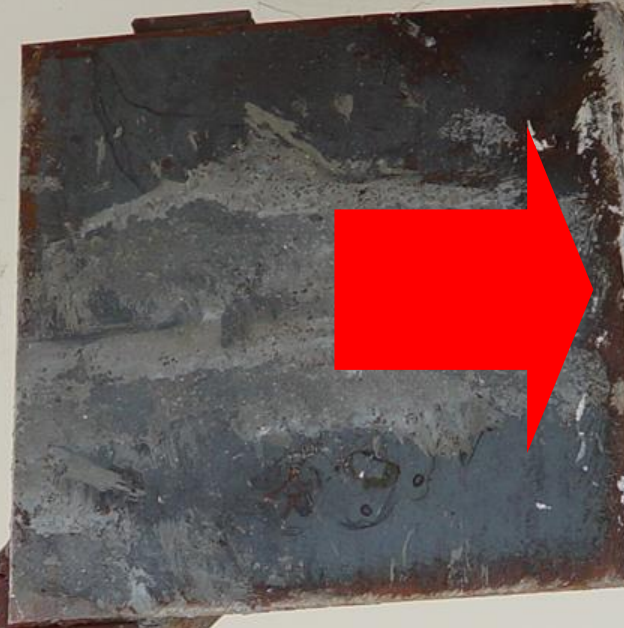
***Causes of Destruction: Stainless Weld - Failure to properly connect the walls to metal columns***

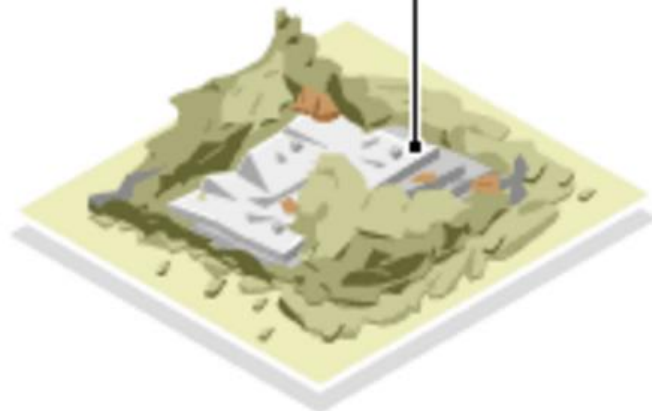
### TRADITIONAL HOUSES IN BAM

Heavy roof sealed with  
cement

Steel roof  
girders

Extra floor added  
to increase living  
space

Mudbrick walls,  
no support beams

Earthquake causes bricks to  
separate and crumble

Roof and girders  
crush floors below
