A Decision Support System for Condition Assessment of Concrete Buildings

**NATIONAL INSTITUTE OF TECHNOLOGY TRICHY
TAMILNADU, INDIA**

AEI CONFERENCE OKC | April 11-13 2017

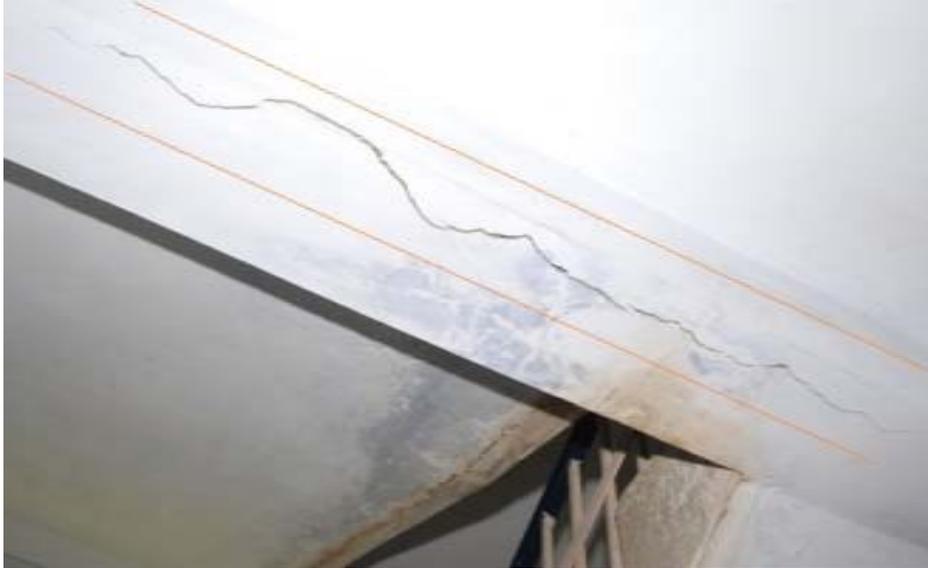
Fig a. Longitudinal crack in beam

S.No	Crack Type	Member Type	Fig. No.	Symptoms observed	Diagnoses from ConAsCon-16
1	Longitudinal Crack	Beam	a	<ul style="list-style-type: none">• Crack parallel to reinforcement.• Rust stain observed around the crack.• No contact with chemical resources.	Corrosion of reinforcement due to oxygen in air.
2	Diagonal Crack	Wall	b	<ul style="list-style-type: none">• The crack starts from a reentrant corner (near opening).• It runs throughout the wall.• It doesn't have split ends.• Wider crack	Due to ground motion or Instable soil strata below the building.

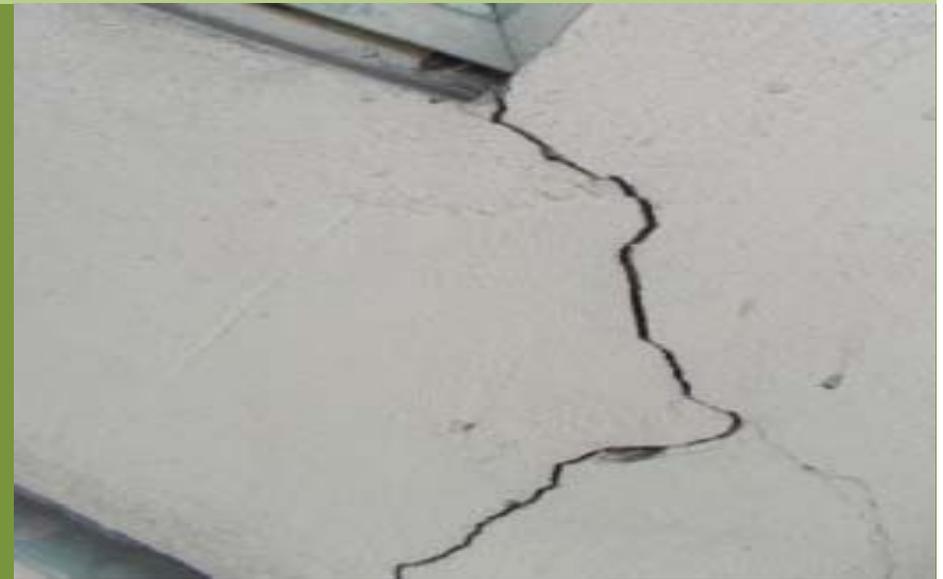
Fig b. Diagonal crack in Wall from opening

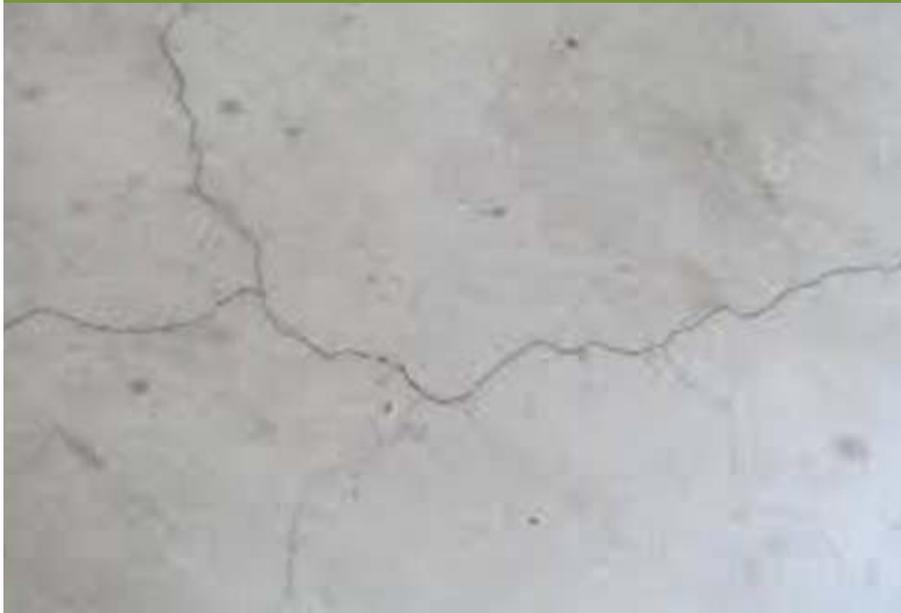
Fig c. Random crack in Floor slab

S.No	Crack Type	Member Type	Fig. No.	Symptoms observed	Diagnoses from ConAsCon-16
3	Random Crack	Slab	c	<ul style="list-style-type: none">•Have randomly interconnected finer cracks.•No sign of bulging	Drying Shrinkage
4	Transverse Crack	Beam	d	<ul style="list-style-type: none">•Grouping of cracks•It runs from soffit to the centre of beam.•Doesn't have split ends	Inability of beam to resist flexural load.

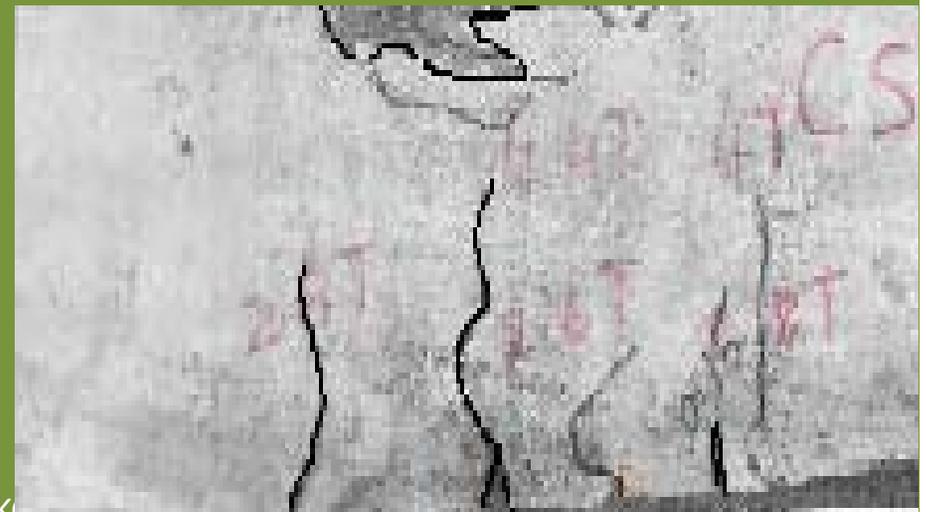
2011 Fig d. Transverse crack in beam
