AEI CONFERENCE 2017

TOWARD A STRUCTURAL COMPREHENSION OF AN 18TH CENTURY SPANISH COLONIAL STONE MASONRY MONUMENT: THE CHURCH OF MISSION SAN JOSE Y MIGUEL DE AGUAYO, TEXAS

Angela Lombardi & Saadet Toker-Beeson
University of Texas at San Antonio

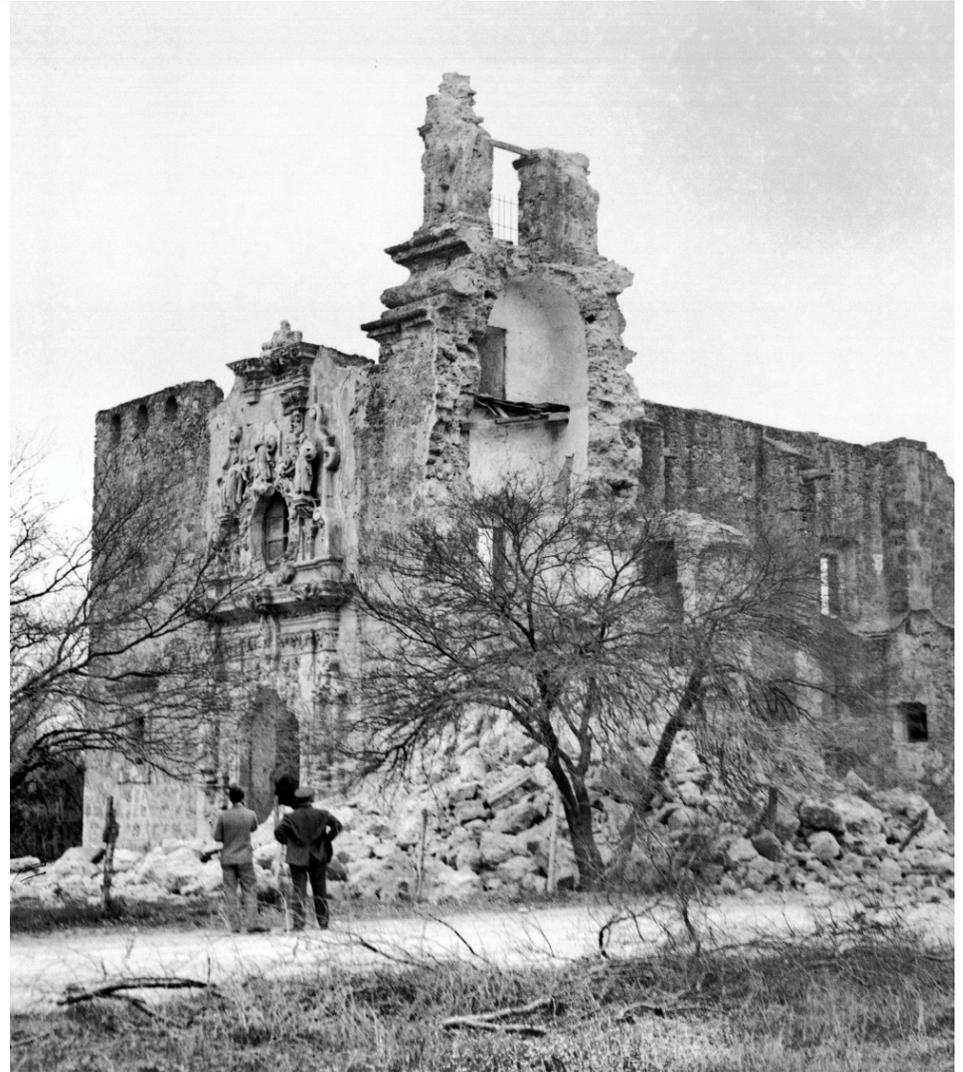
- On December 10, 1864, part of the North wall of the church collapsed.
- The roof crashed on December 25, 1874, during Christmas celebrations on a stormy night (Habig, 1958).
- The steps of the spiral staircase beside the tower had laid scattered since 1903, they were put back in 1920 (Habig, 1958).
- The tower had in some way lost its structural integrity. On March 9, 1928, the bell tower also collapsed. The tower reconstruction was the first of a series of projects, which lasted until 1941.

- Storms are one of the causes of structural damage and can be considered one of the causes of collapse, since internal pressure results when a breach occurs in the windward side of a building.

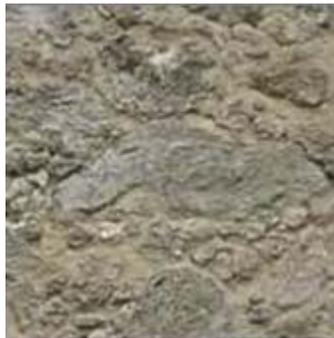
Masonry samples are 1mt x 1mt

- Original 18th century masonry, still in place on the main façade (west), is characterized by:
 - - presence of small livers of stones (in Spanish: *rajuelas*) between the mortar joint;
 - - irregular horizontal courses to improve and strengthen the masonry.
- -Original mortar is lime based,
- with yellowish color and friable.
- Façade is finished
- with remnants of stucco.

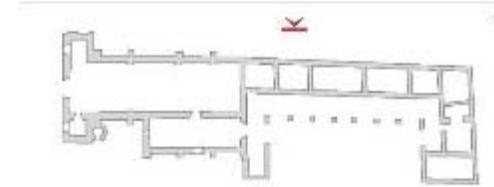
Northern photo elevation:
In blue - original walls

- Reconstructed 20th century masonry on the northern wall is also made of irregular lime stones.
- - No small slivers of stones or horizontal courses have been observed;
- - Possible adoption of cement-based mortar;

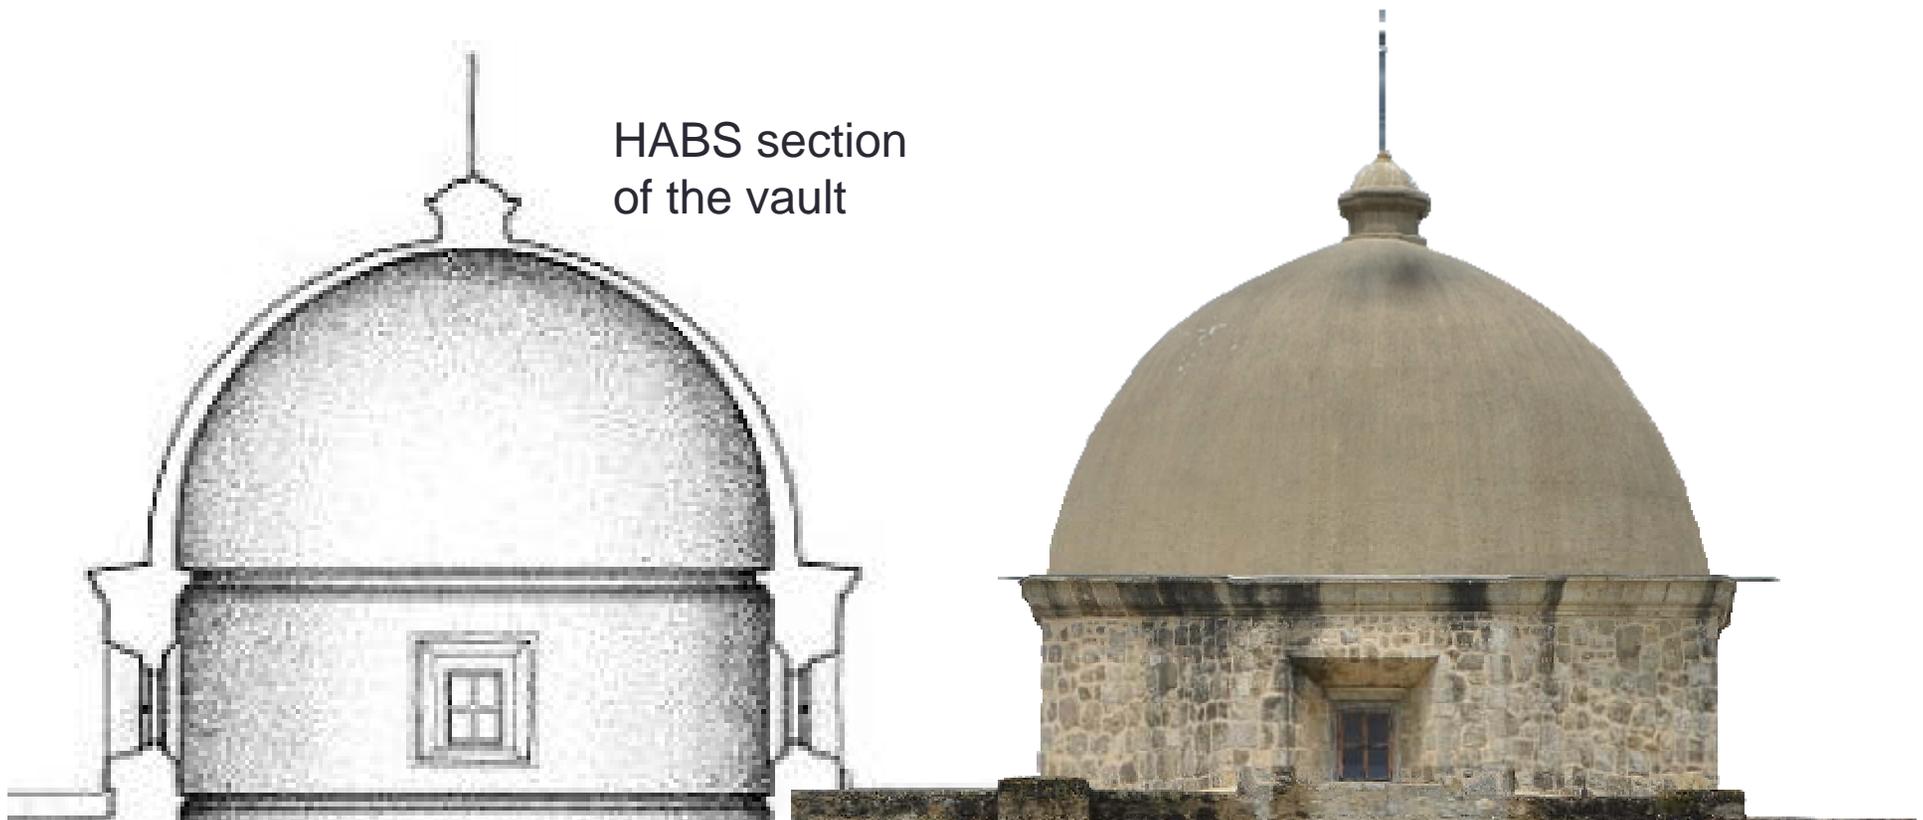
Notes on reconstruction

The HABS drawings, drafted by Harvey P. Smith after the church reconstruction, show an extremely thin dome section, the adoption of reinforced concrete.

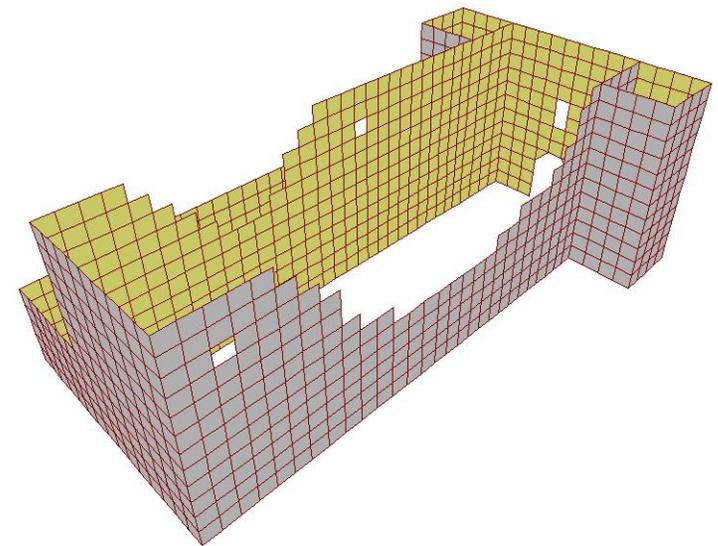
Finite element model
of the collapsed structure

- Gravity and wind loads applied.
- Finite element models have been developed to represent the collapsed and repaired conditions of the structure.
- Using the most unfavorable conditions, wind loads have been applied on the structure as a combination of:
 - **1.44 kN/m² windward** and
 - **0.86 kN/m² leeward pressure** (Ochshorn, 2009).
- All the results have been given and discussed as a **combination of gravity loads and wind loads (G + W)**.

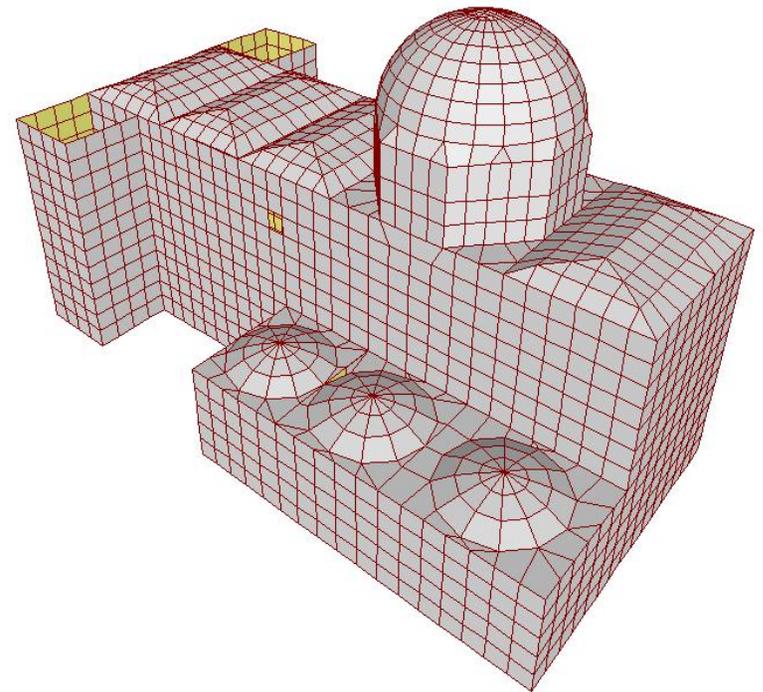
Finite element model
of the reconstructed structure

- The majority of the structure, mainly the vaults and walls, have been **modeled by linear elastic SHELL elements**.
- The model has been prepared by using **2,366 nodes and 2,414 SHELL elements**.
- **‘Thick shell’ option has been chosen for the members** that represent the thick walls. This option enables obtaining more detailed stress values both at the exterior surfaces and within the inner section.

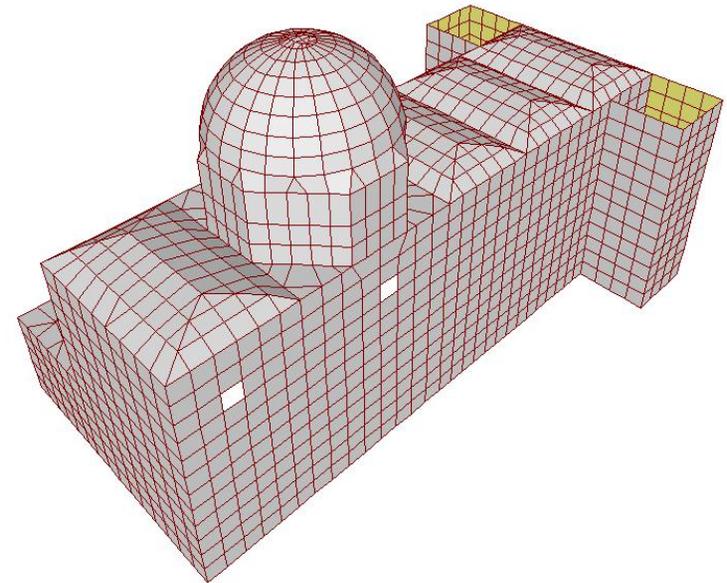
Finite element model of the reconstructed structure

- **Boundary conditions** of structural model have been expressed as fixed supports, which demonstrate actual soil conditions.
- **Properties** of the structural materials have been obtained from international literature regarding similar type of structures (Borri et al., 2008).
- **Modulus of Elasticity** values and **unit weights** have been specified with the **assumption of perfect unity between mortar and brick or stone masonry units.**
- **450 MPa** for stone masonry vaults and dome
- **28500 MPa** for reinforced concrete dome and vaults
