Bridge Failure

Bridge collapse

A.E. Schultz, A.J. Gaslini, A.J. Gaslini, in [Design Handbook](#), 2016

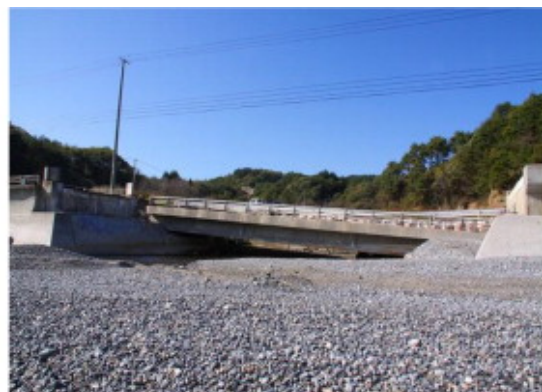
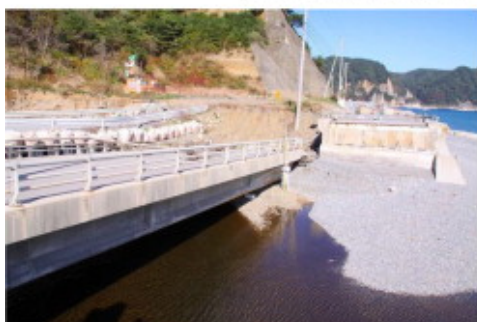
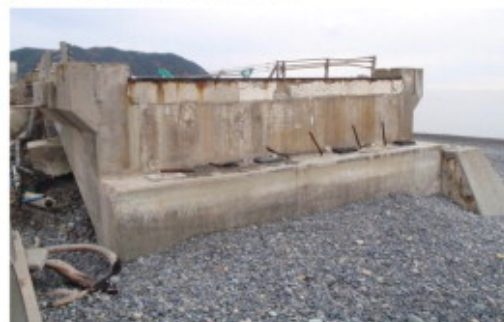
Figure 17. Damaged Hirouchibashi Bridge in Noda-Mura, Iwate Prefecture. Top photo is looking inland. The bottom left photo shows the bridge deck displaced inland (left). The bottom right shows the anchor bars bent inland.

Another type of bridge failure is the damage of reinforced concrete girder bridges located near the beach. The Noda-Mura bridge of Noda-Mura in Iwate Prefecture is shown in Figure 3.1a, positioned 17 m above the river with only 2.4 m clearance above the river. Highway bridge, the deck was not overturned but moved horizontally and severely damaged the anchor bars that restrained horizontal movement of the deck. This suggests that the deck was lifted up and then moved horizontally as it was pushed horizontally. Previous studies of tsunami wave forces on bridges (Kosa et al., 2011; Shoji et al., 2010; Shoji et al., 2010) indicate that the wave forces are mainly horizontal, and the vertical uplift force is only for a short period when plunging waves impinge on the structure. The Noda-Mura bridge may have taken the form of a high flow, but the high flow reports of plunging waves. In order to investigate the effects of waves and flows on this type of failure, numerical simulations of various scenarios were conducted.

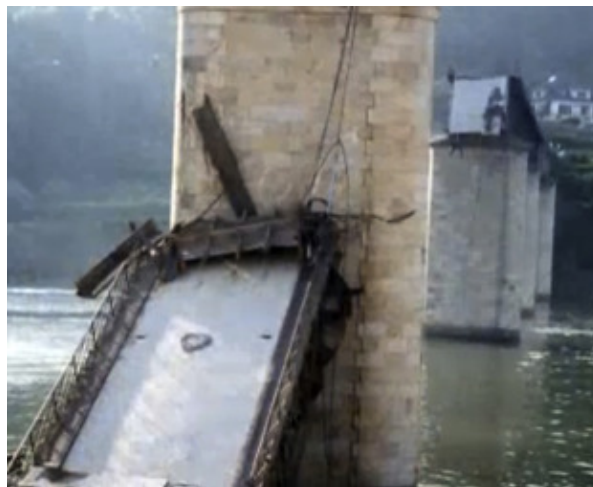
Figure 31.16. Hintze Ribeiro Bridge collapse (Photo: Enciclofurgo).

The Hintze Ribeiro Bridge in Portugal, built in 1887, collapsed in 2001 (Figure 31.16), claiming the lives of 59 people traveling in cars and trucks. The steel truss bridge with superimposed deck supported by granite piers on timber piles, spanning 336 m over the Douro River in Portugal. The stability of one of the piers was compromised by the overmining of the river depth due to a combination of sand mining and sand operations (Solaz and Bastos, 2013; Antunes do Carmo, 2014). The lower water level of the foundation of the pier and the eventual collapse of the bridge led to the collapse of the pier and the eventual collapse of the bridge. The collapse led to immediate inspections and repair of bridges around Portugal.

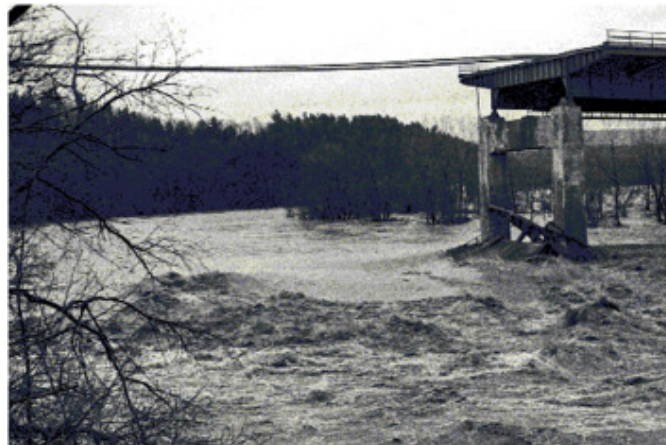
Figure 31.17. Schoharie Creek Bridge pier collapse (USGS, 1997).

Scour, the removal of soil from the riverbed by river flow, caused the collapse of the Schoharie Creek Bridge (Figure 31.17) in 1987 in the United States (Storey and Delatte, 2003). The bridge was a steel truss bridge supported by closely spaced floor beams and longitudinal stringers. The scour, estimated to have been 8.5 m to 13.5 m deep, undermined the support of one of the piers introducing unexpected stress, which led to the collapse of the bridge. The collapse was a failure (Swenson and Ingraffea, 1991). Additionally, a flow was suspected to have contributed to the failure (Hairs and Zabilsky, 2006). The span, falling into the river, killing 10

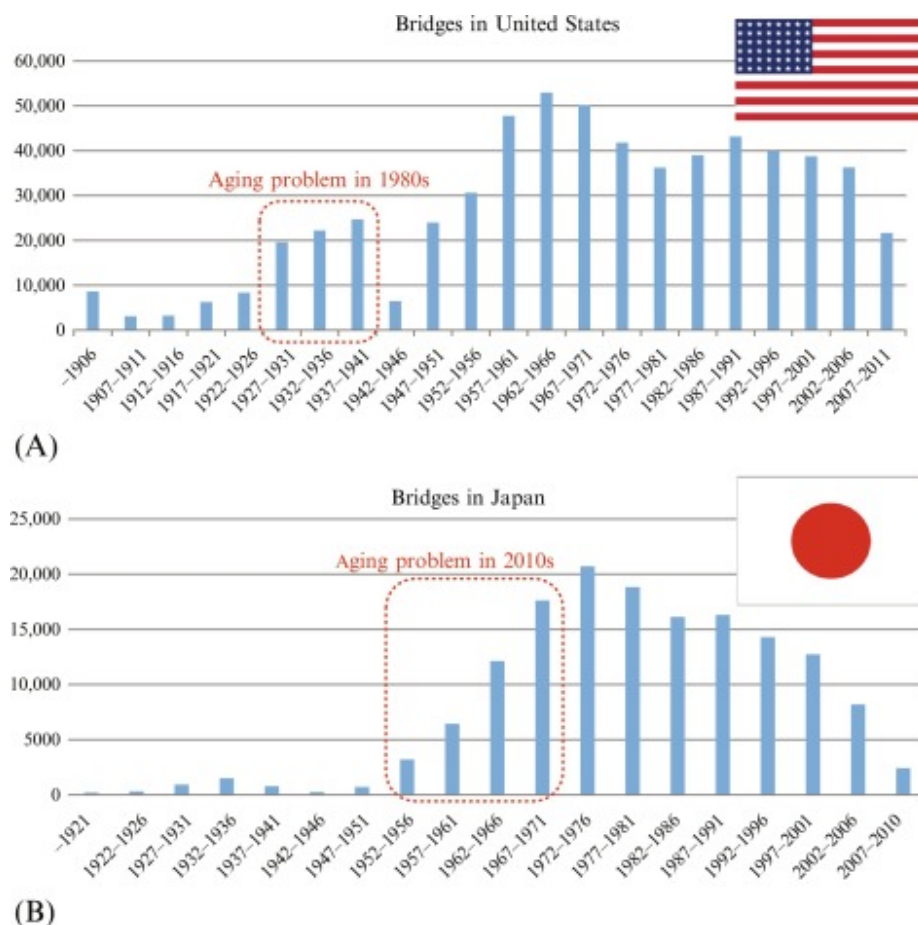
Fig. 14.1. Bridge inventory in the United States and Japan. (A) Bridge stock in the United States. (B) Bridge stock in Japan.(Courtesy of MLIT.)

In recent years, the rapid deterioration of structures has become a serious technical and economic problem, including both developed and developing countries. As shown in Fig. 14.1(A), the bridge built in the United States between the 1920s and 1940s deteriorated severely in the 1980s and resulted in the publication of the book "Aging Infrastructure: The Declining Infrastructure" (Choate and Walter, 1983). In Japan, bridges repaired during economic growth period between 1950s and 1980s started to exhibit deterioration in the 2010s, as can be found in Fig. 14.1(B). Since the term "Aging Infrastructure" has also become a concern. Taking the bridge older than 50 years (the bridge design service life) in Japan as an example, the ratio has increased from 6% in 2006 to 20% in 2016, and it is predicted to be 47% in 2026 and 47% in 2026, as shown in Fig. 14.2.
